HONOAPI'ILANI HIGHWAY IMPROVEMENTS PROJECT,
WEST MAUI: UKUMEHAME TO LAUNIUPOKO

Appendix 3.9 – Water Resources, Wetlands, and Floodplains - Supplemental Information

**Honoapiilani Highway Improvement Project
Preliminary Identification of Waters of the United States
Technical Report**

Project # 4692-02

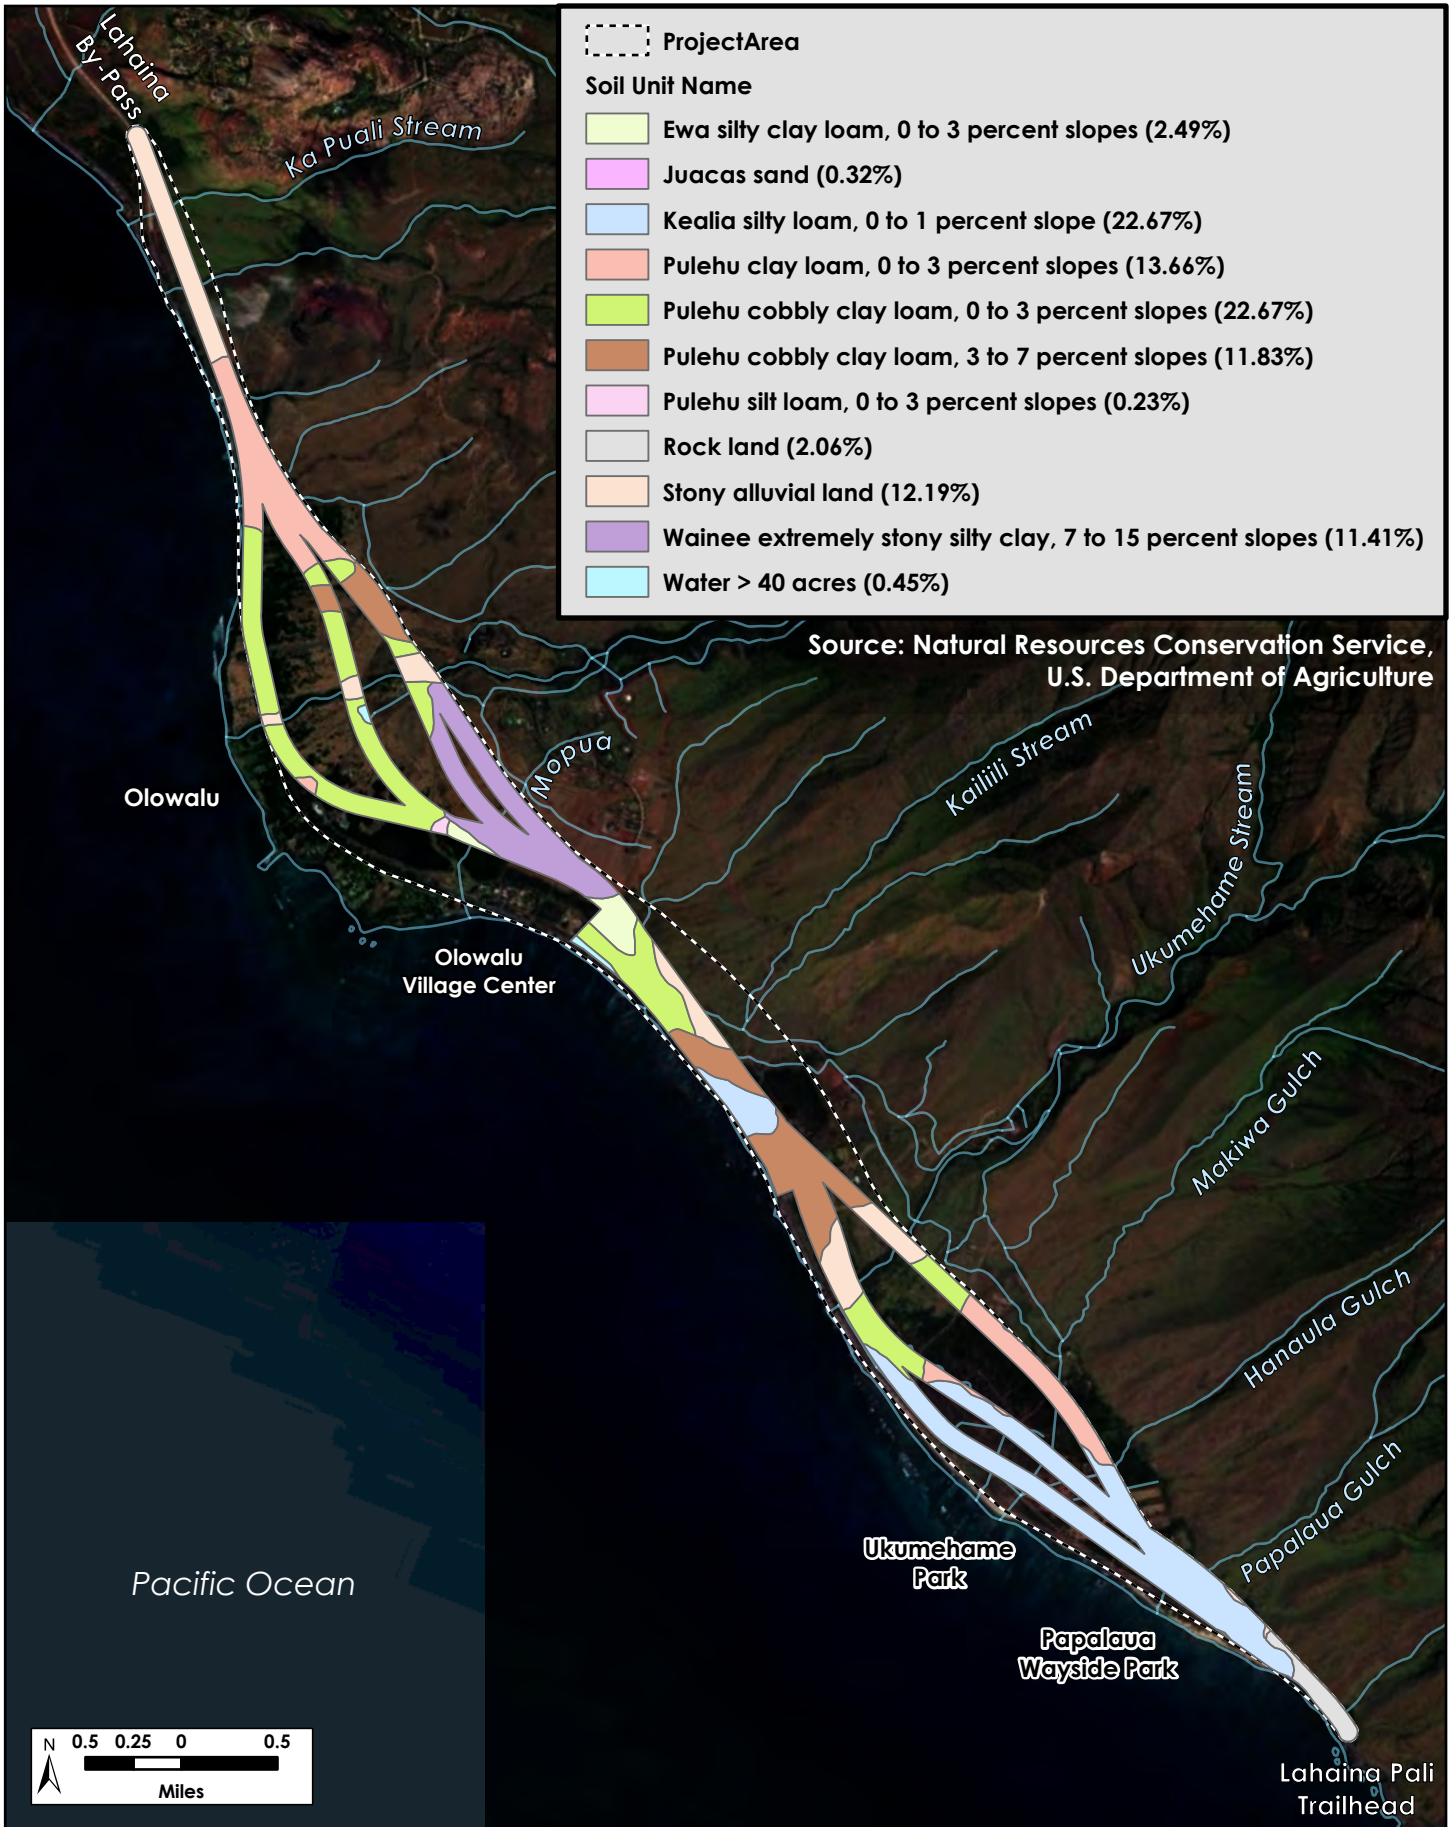
Figure 4. Soils Map
Honoapiilani Highway (4692)
September 2023

Eleven soil units are mapped by the Natural Resources Conservation Service (NRCS) within the study area (Figure 4). Table 1 summarizes the associated texture, drainage classification, landform setting, and hydric soil status (NRCS 2023a) for these soil types found within the study area.

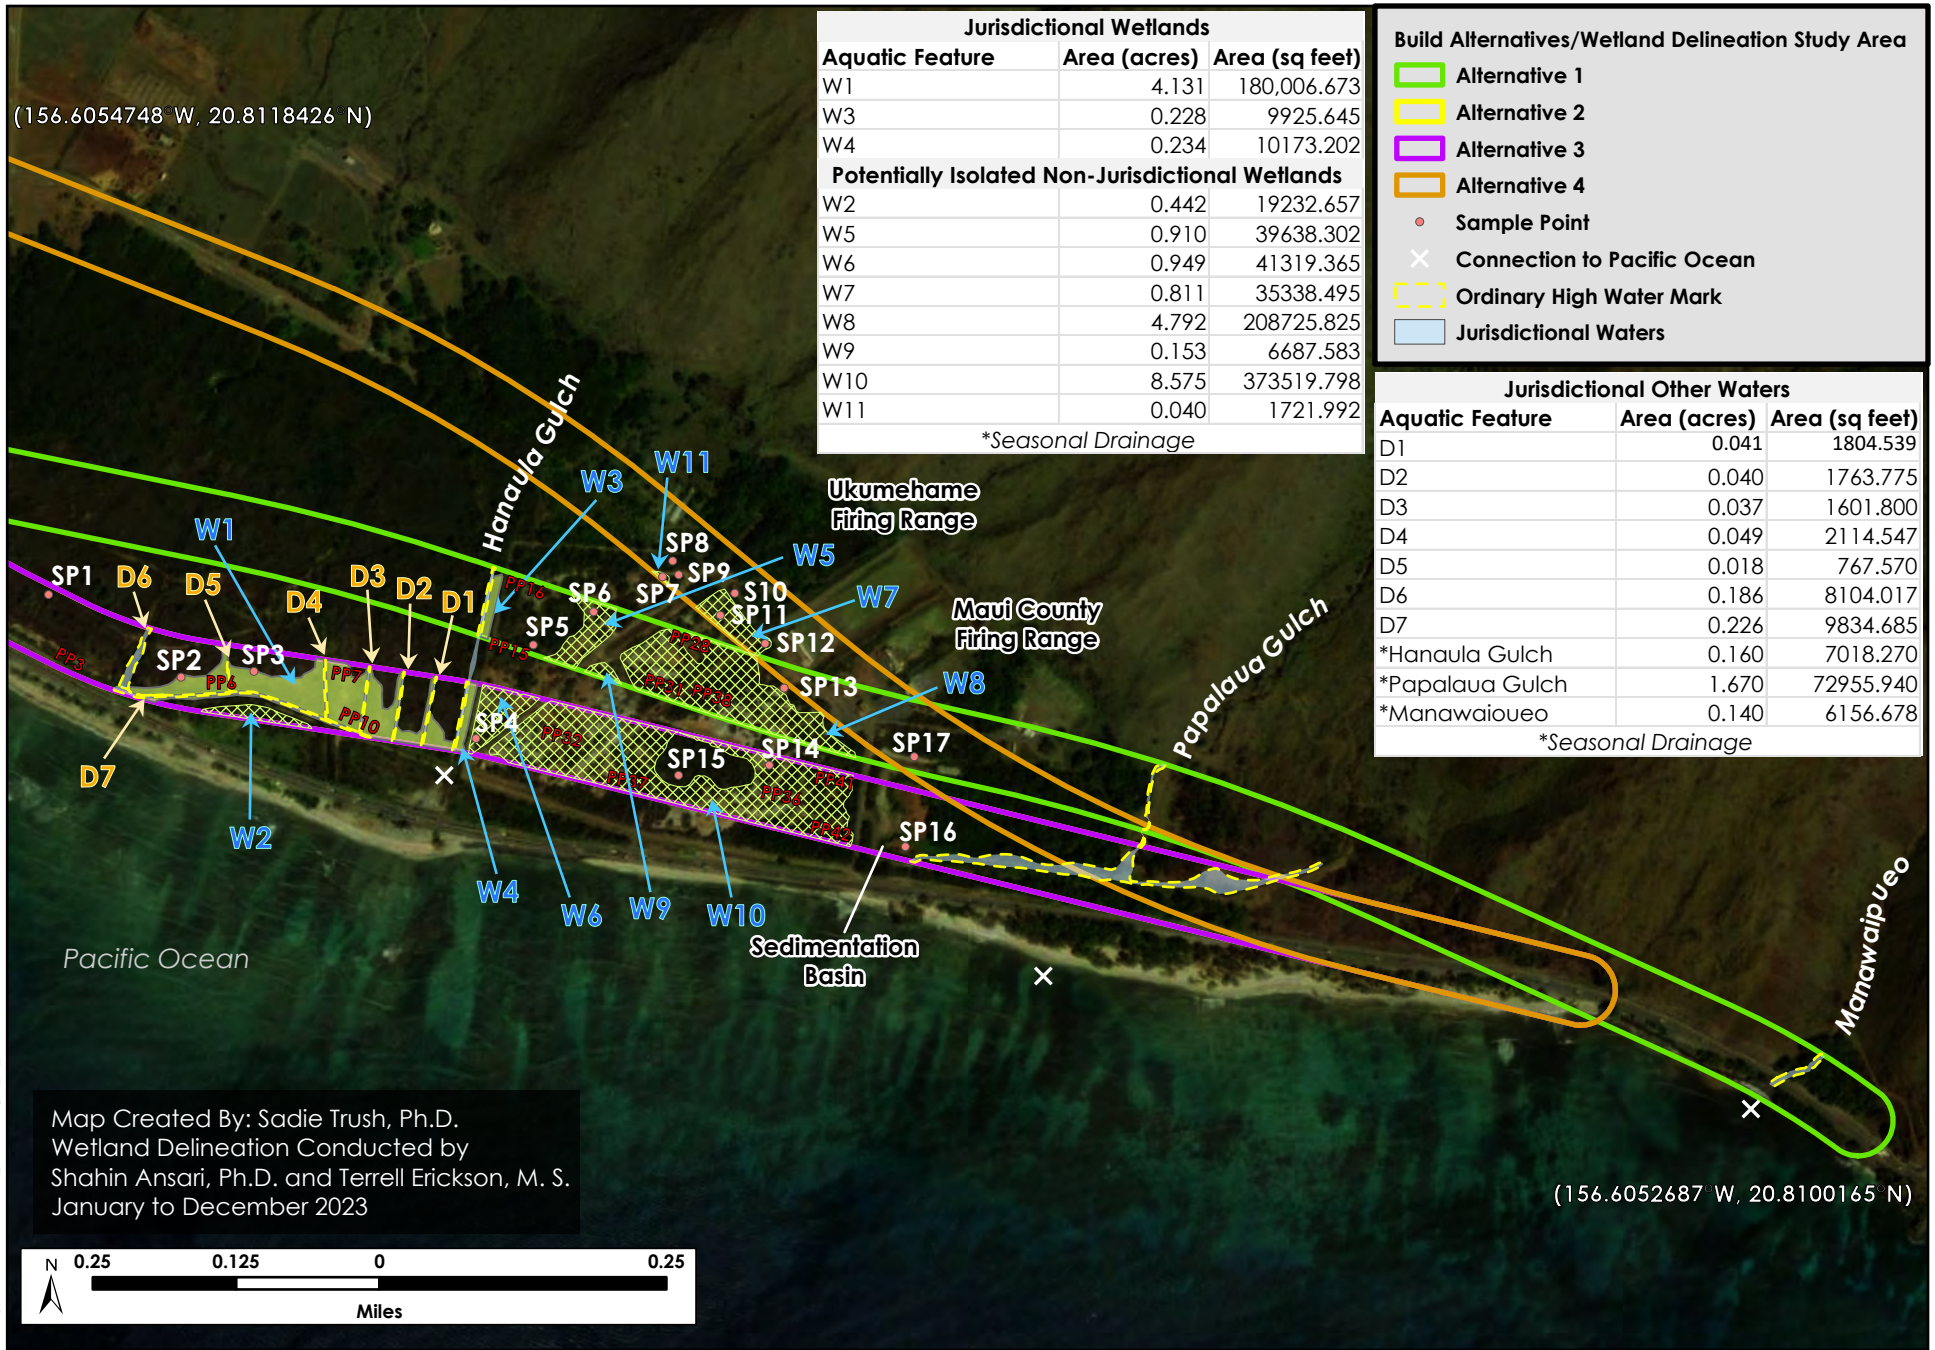
Figure 7. Preliminary Identification of Jurisdictional Wetlands, Potentially Isolated Non-Jurisdictional Wetlands, and Jurisdictional Other Waters in the Palalau and Ukumehame Portions of the Wetland Delineation Study Area

The third vegetation community that met the three parameter wetland criteria was generally dominated by a mix of facultative *Pluchea* spp. and saltbush, along with FACU species of finger grass. There was also a mix scattered live and dead kiawe trees (FACU) that formed an open canopy. These areas were generally also showed prominent signs of hydrology such as salt crust and soil surface cracks. SP11 (Appendix C, Photos 29-32), SP14 (Appendix C, Photos 34-38), and the areas around the upland “island” (represented by SP 15) contained this wetland habitat type (Figure 7).

Twenty sample points were selected to document conditions in representative jurisdictional and non-jurisdictional areas (Figure 7). Rationale and findings for wetland sample point (Appendix C: SP 1-20) locations are summarized in Table 5. Location of sample points are depicted in Figures 7 and 8. Photos associated with sample points have the same rationale and depiction as sample points and are included in Table 5.

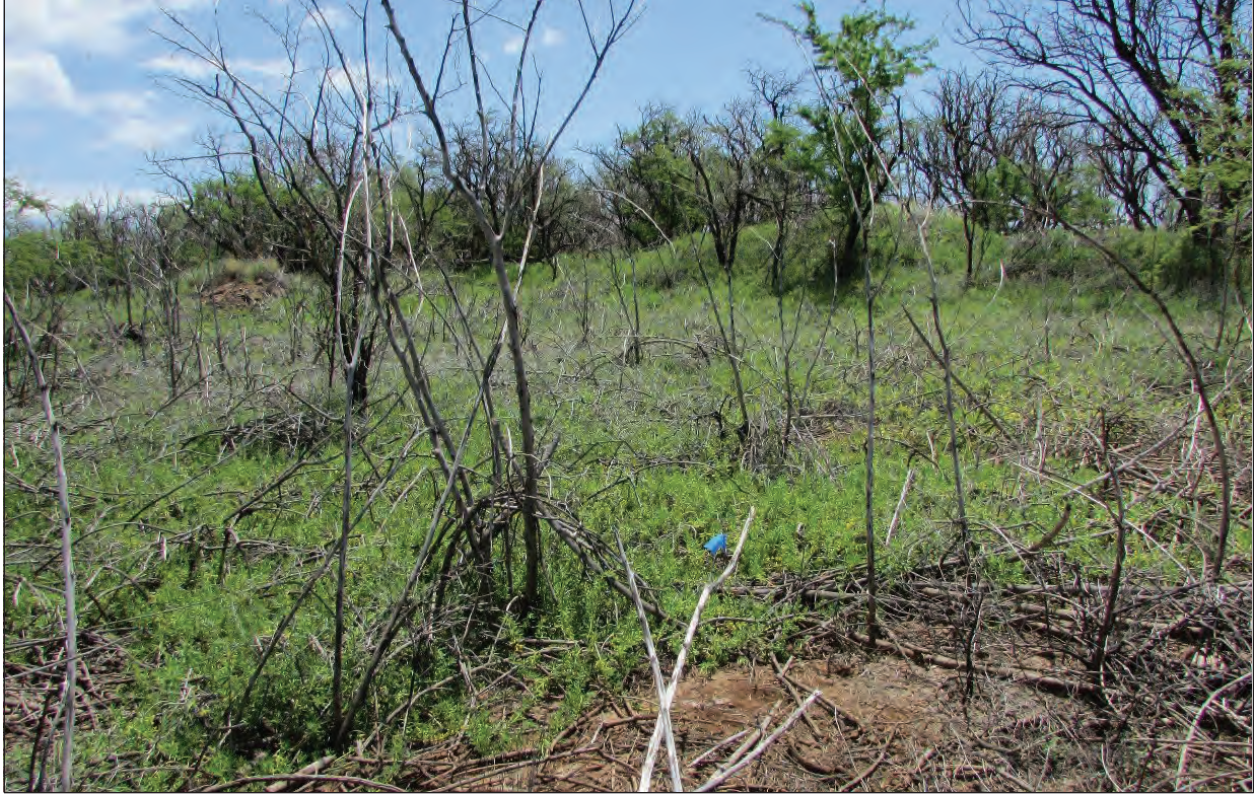
Photo 6. Representative Area between SP2 and SP3 Included in Wetland as Similar to SP2 in Observed Vegetation, Slope, and Hydrology Characteristics

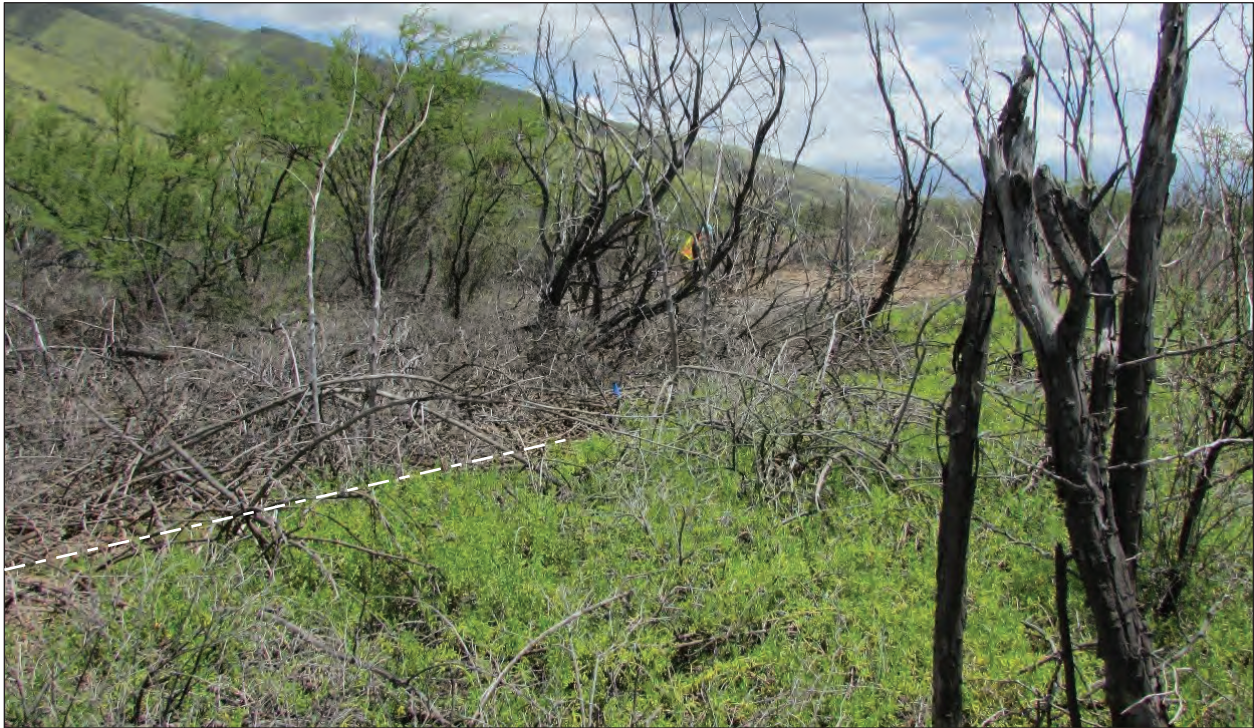
Photo 7. Area South of SP3 Showing Transition (White Dash Line) between Wetland—Right Side with Pickleweed (*Batis maritima*) [OBL] and Dead Kiawe (*Prosopis pallida*) (FACU) Trees and Upland—Upper Left Side with Live Kiawe Trees and No Pickleweed in Understory

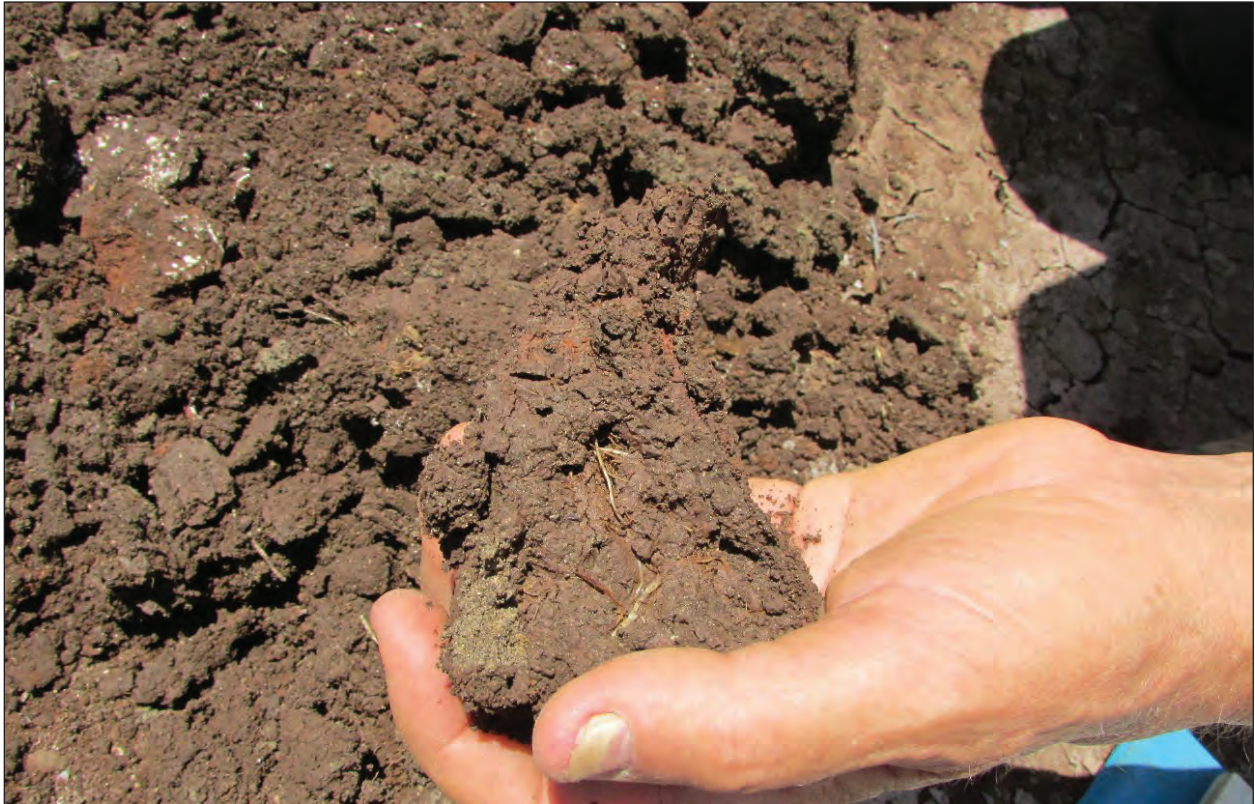
Photo 9. At SP3 - Oxidized Root Channels Observed in Hydric Soils

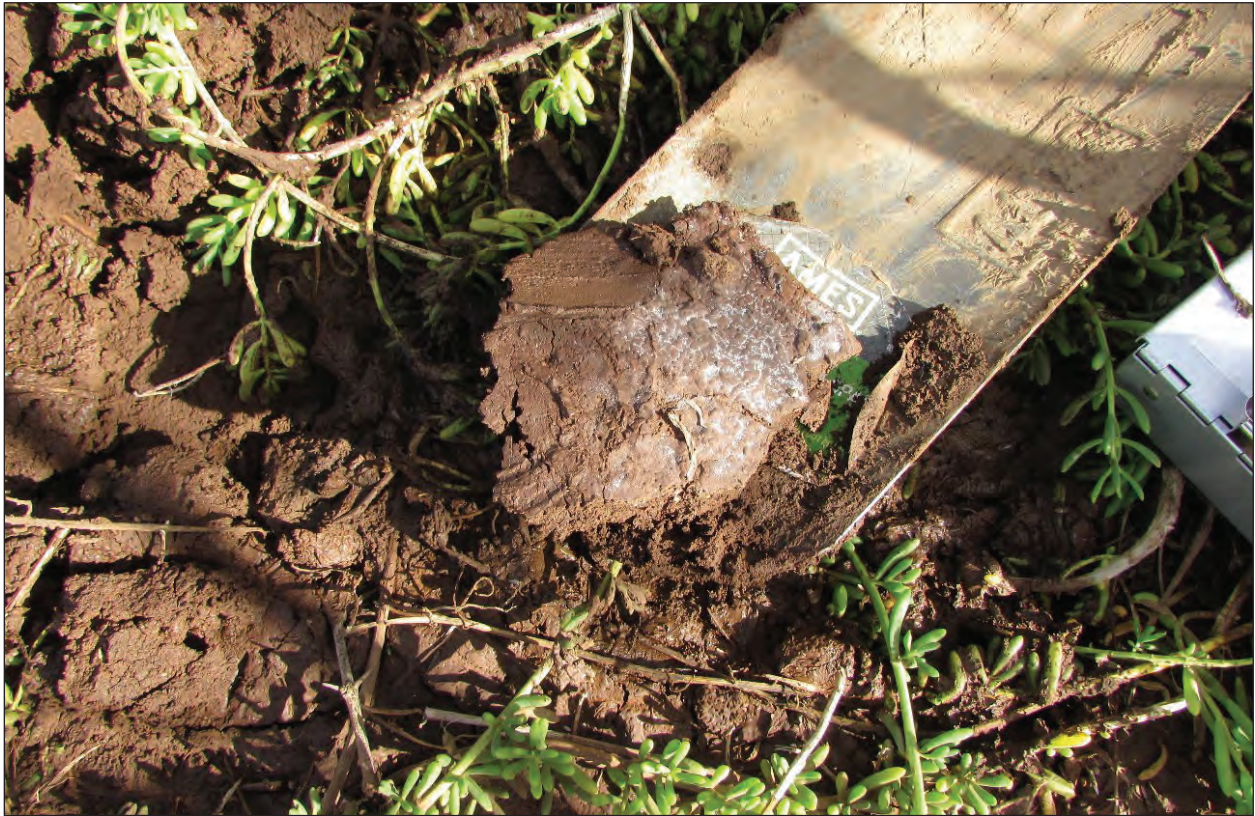
Photo 12. At SP4 - Saturated Hydric Soil Conditions

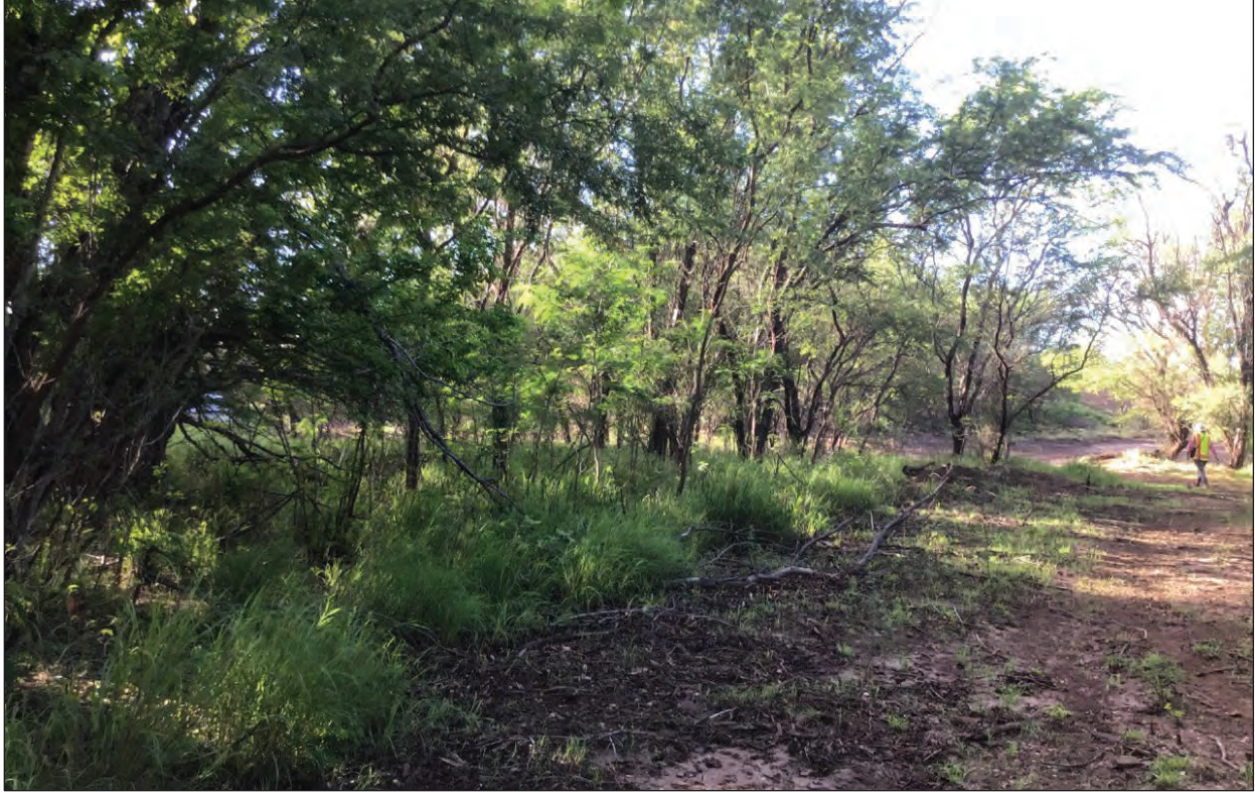
Photo 13. At SP5 - Slightly Elevated Area with Upland Habitat Conditions Similar to that at SP5. Live Kiawe (*Prosopis pallida*) with Predominantly Buffel Grass (*Cenchrus ciliaris*) in Understory

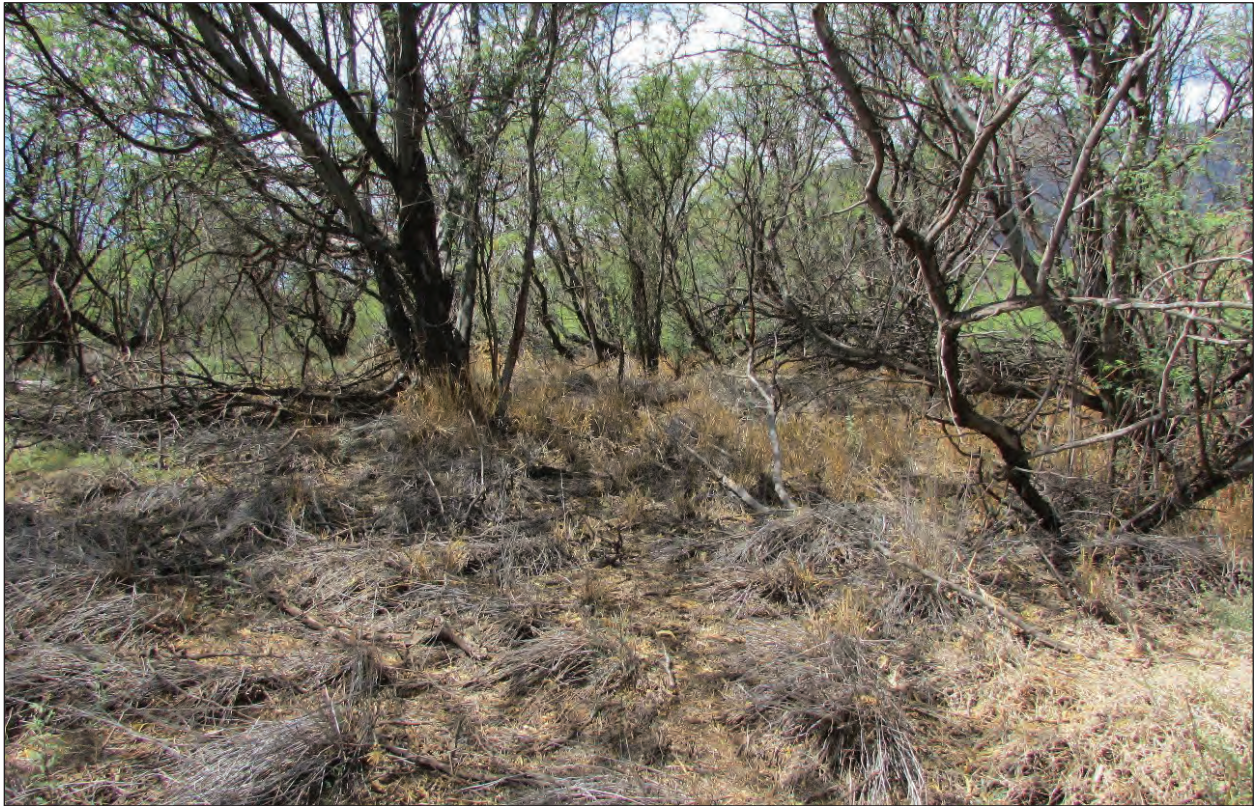
Photo 14. Southeast of SP5 - Habitat Conditions Representative of Similar Uplands Observed at SP5

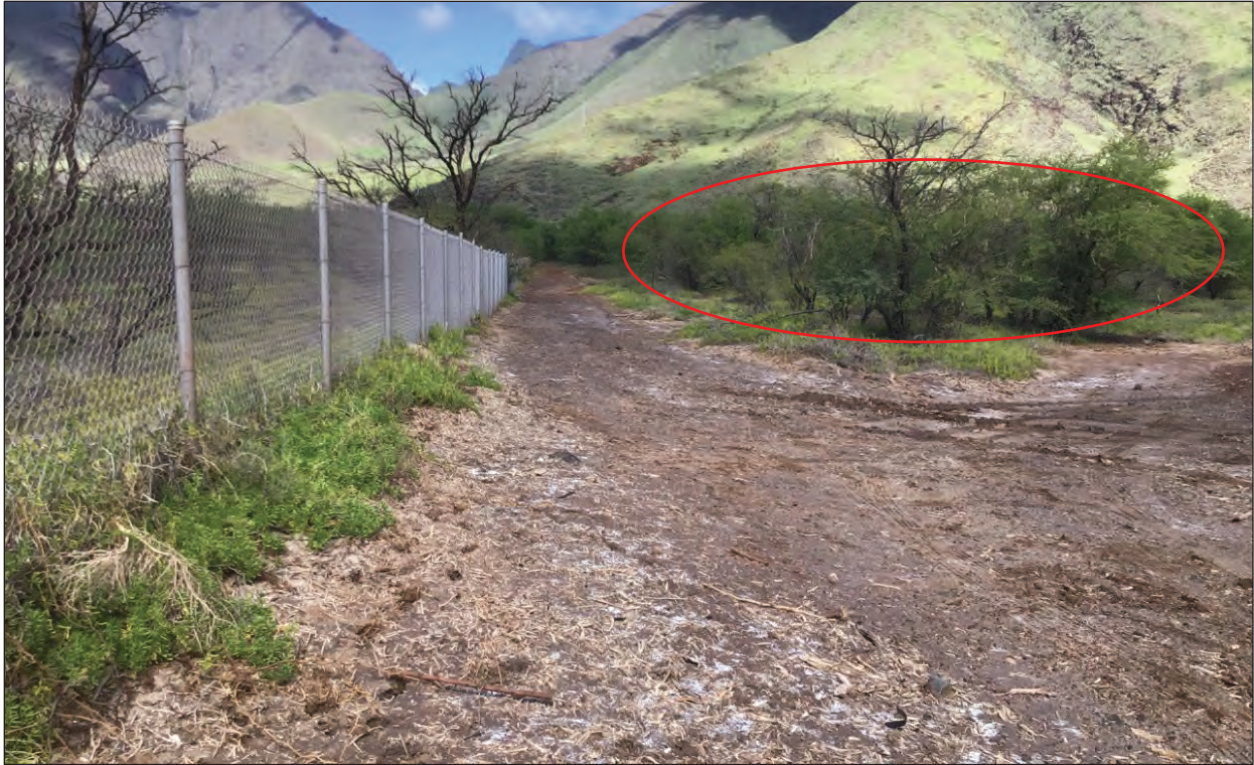
Photo 15. Looking East at Large Kiawe (*Prosopis pallida*) Buffel Grass (*Cenchrus ciliaris*) Area (Red Oval) Excluded as Upland

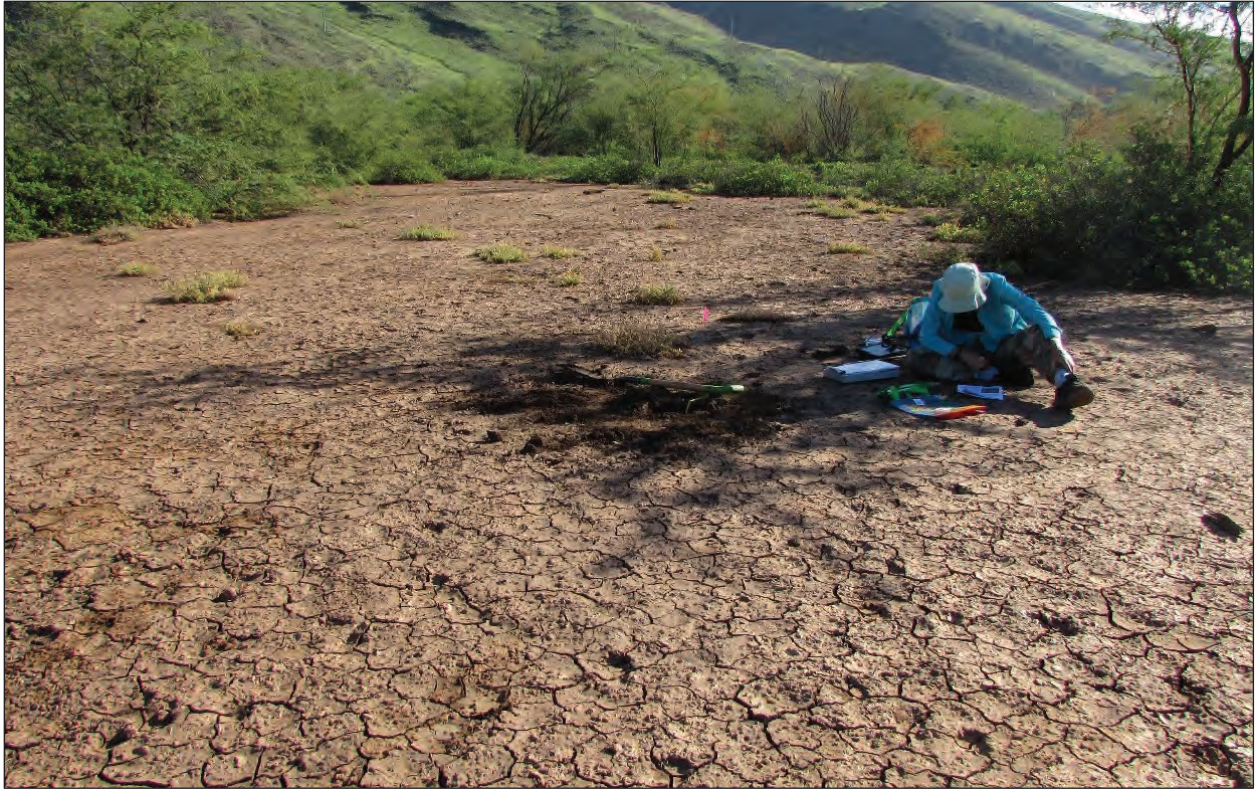
Photo 17. At SP6—View to East; Large Sparsely Vegetated Wetland with Prominent Surface soil Cracks

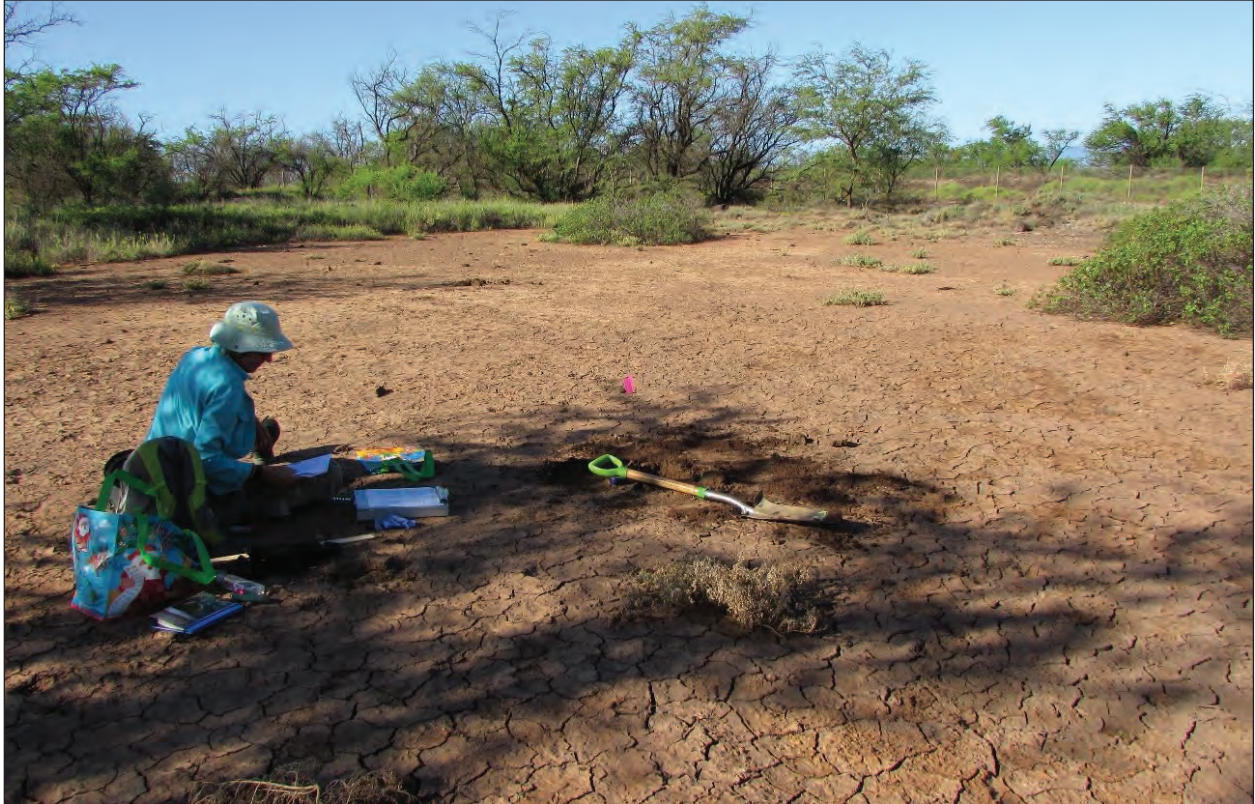
Photo 18. At SP6—View to North. Sparsely Vegetated Wetland Area (Foreground) with Buffel Grass Dominated Upland Area in the Background

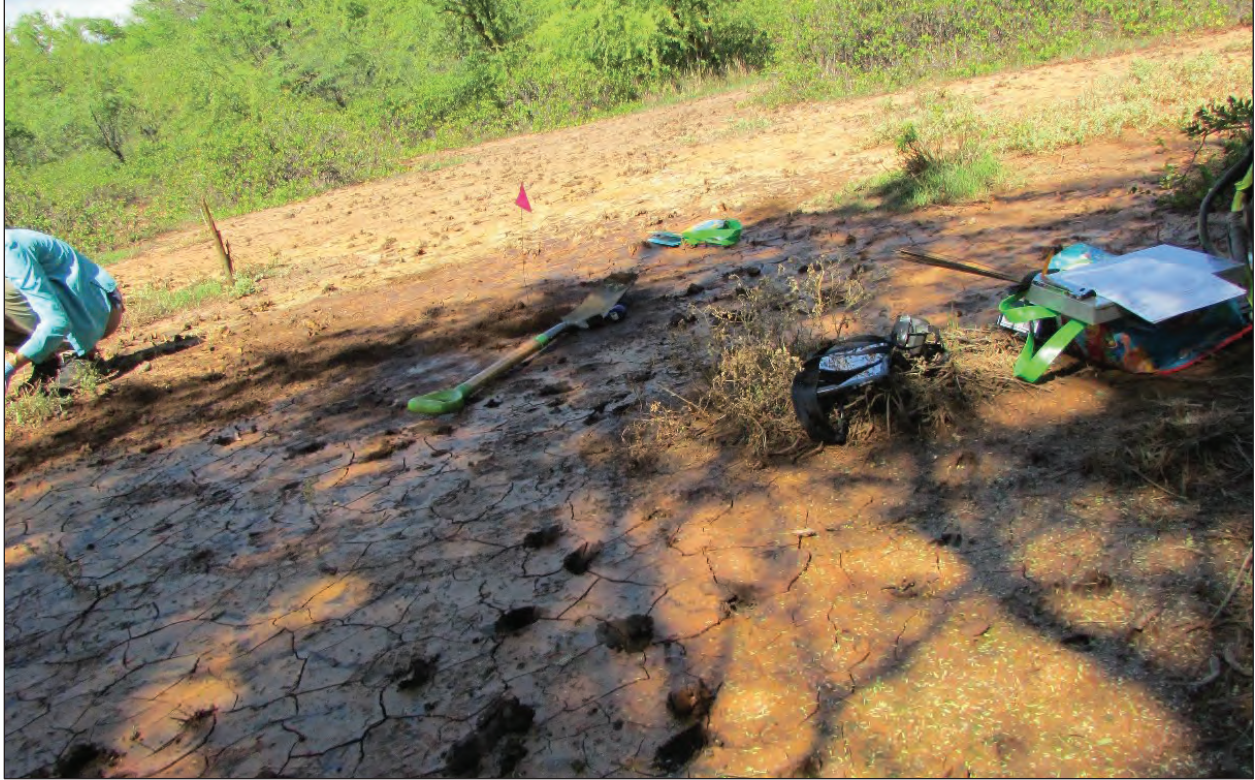
Photo 19. At SP7 - Placed in Sparsely Vegetated Area to Investigate Platy Moist Soils that Had Both Bright Red and Black Soil Surface Colors

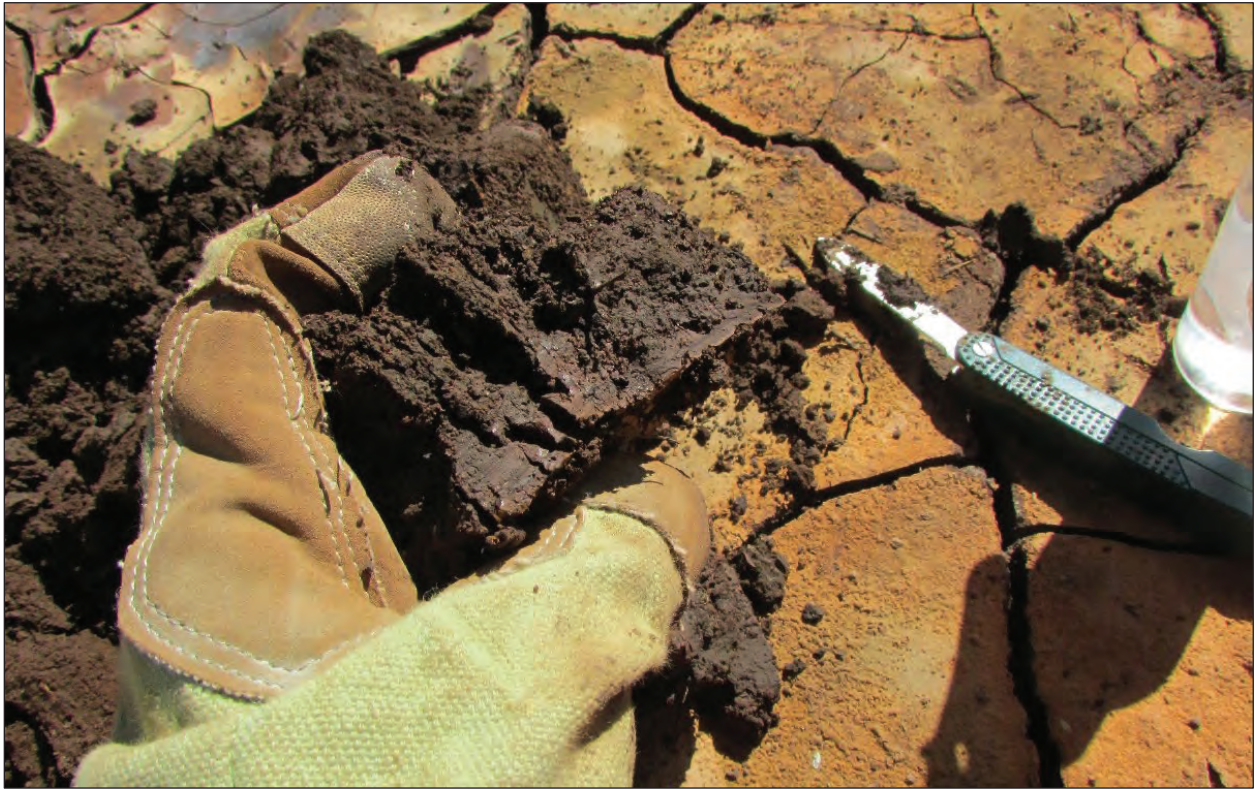
Photo 20. At SP7 - Soil Showed Redox Features of Iron and Manganese on Surface As Well As Mottles in the Matrix

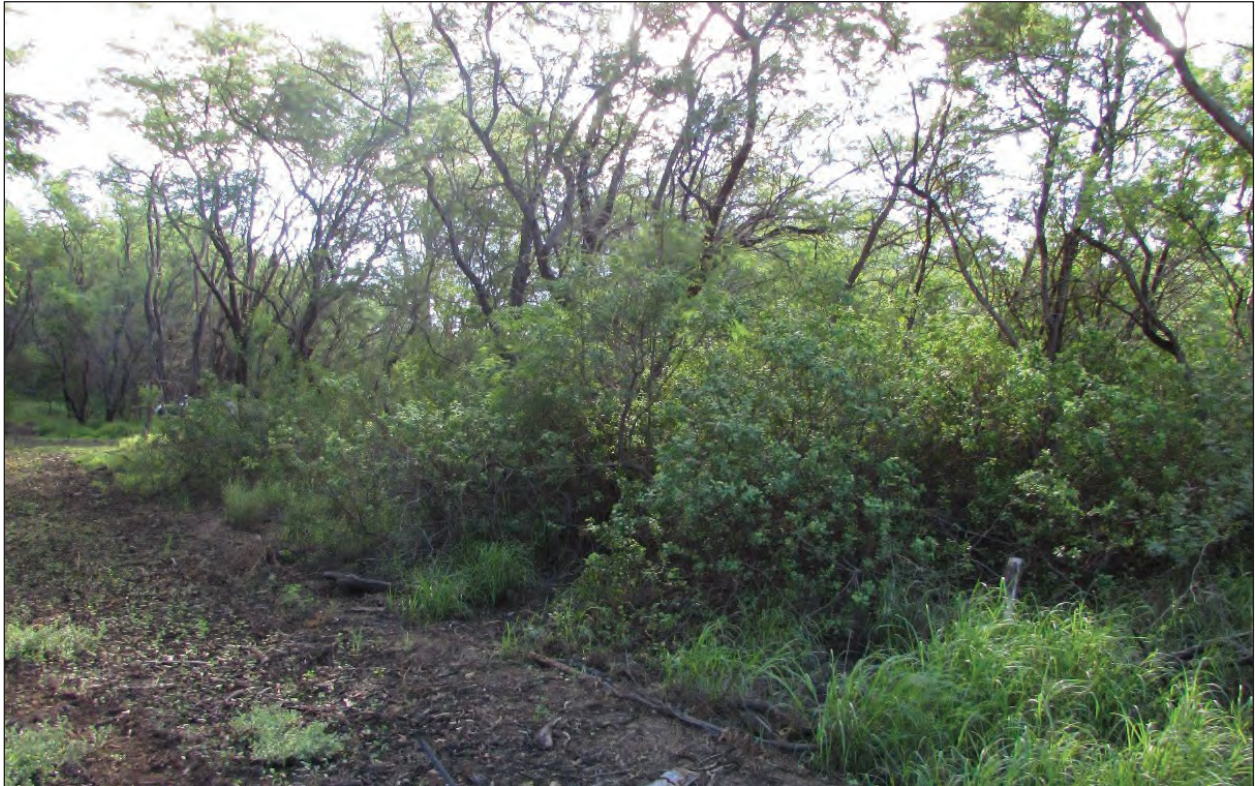
Photo 22. Area around SP8 - Mapped as Uplands Based on Similar Habitat Conditions Observed at SP8

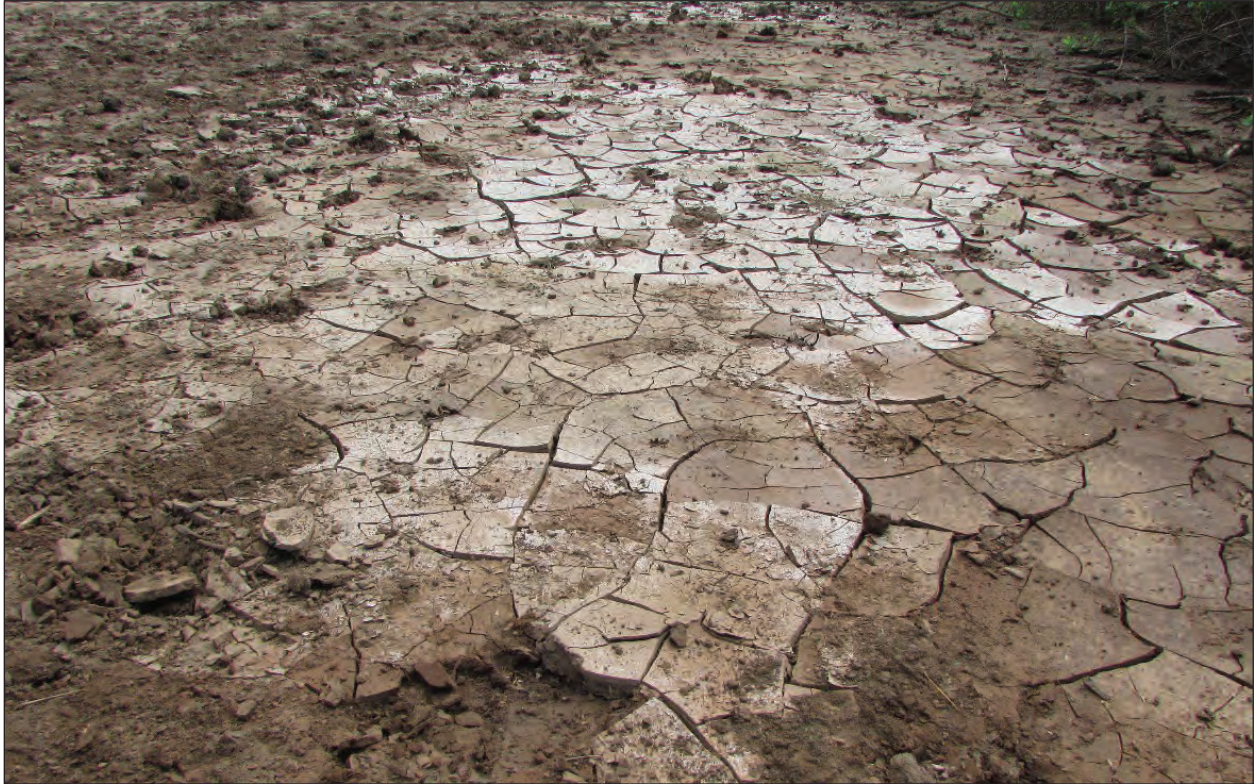
Photo 25. At SP9, Platy and Crack Surface Soils that were Not Hydric and Area Excluded as Wetland as It Did Not Meet the Three Parameter Wetland Criteria

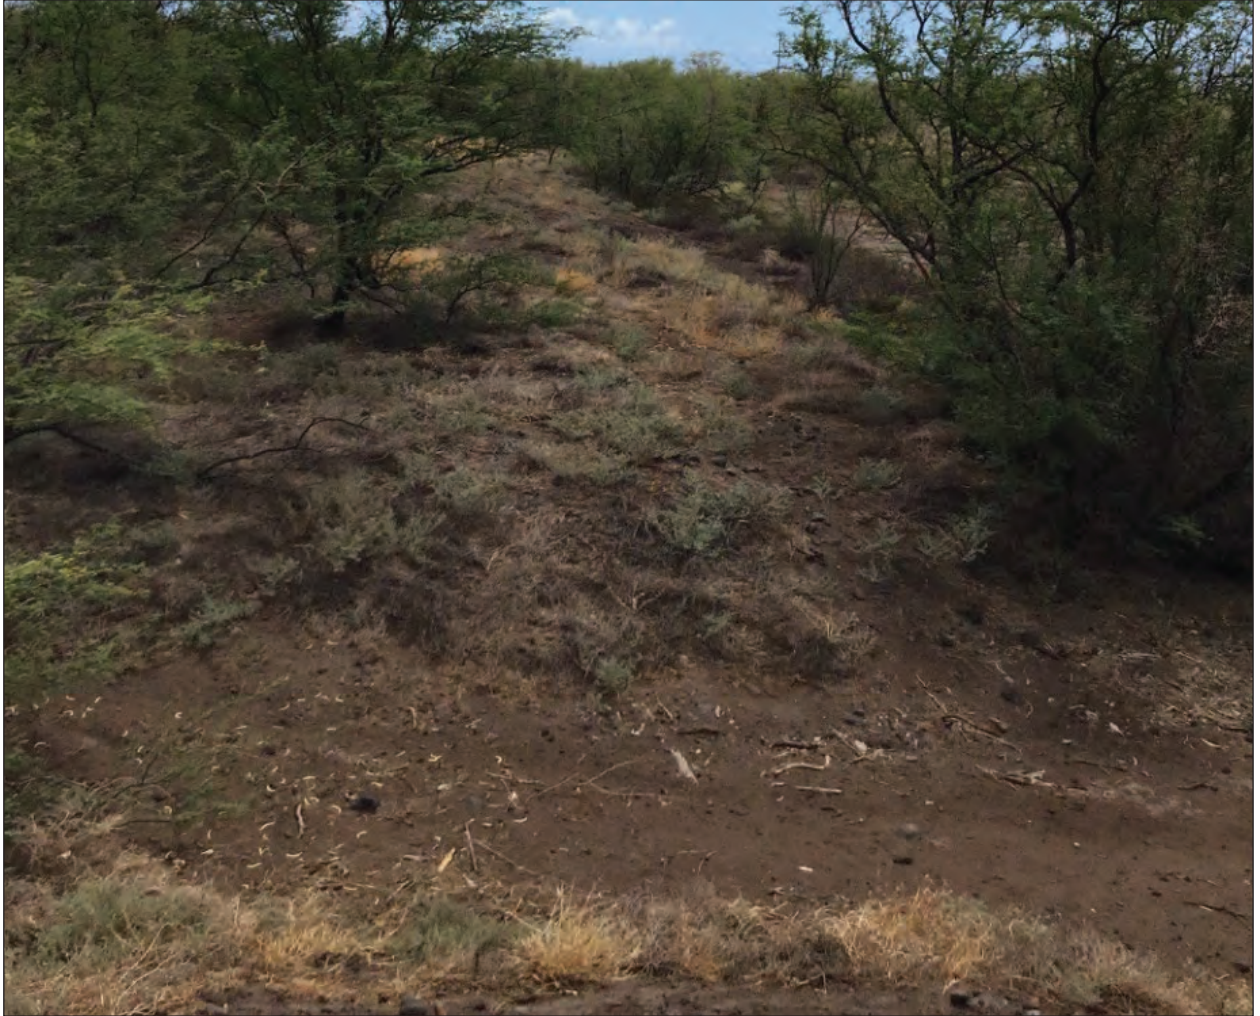
Photo 28. View to South, Photo of **Second Berm (From East)** that was Excluded as Upland Based on Similarities in Habitat, Slope, and Hydrology Observed at the SP10 Berm Site

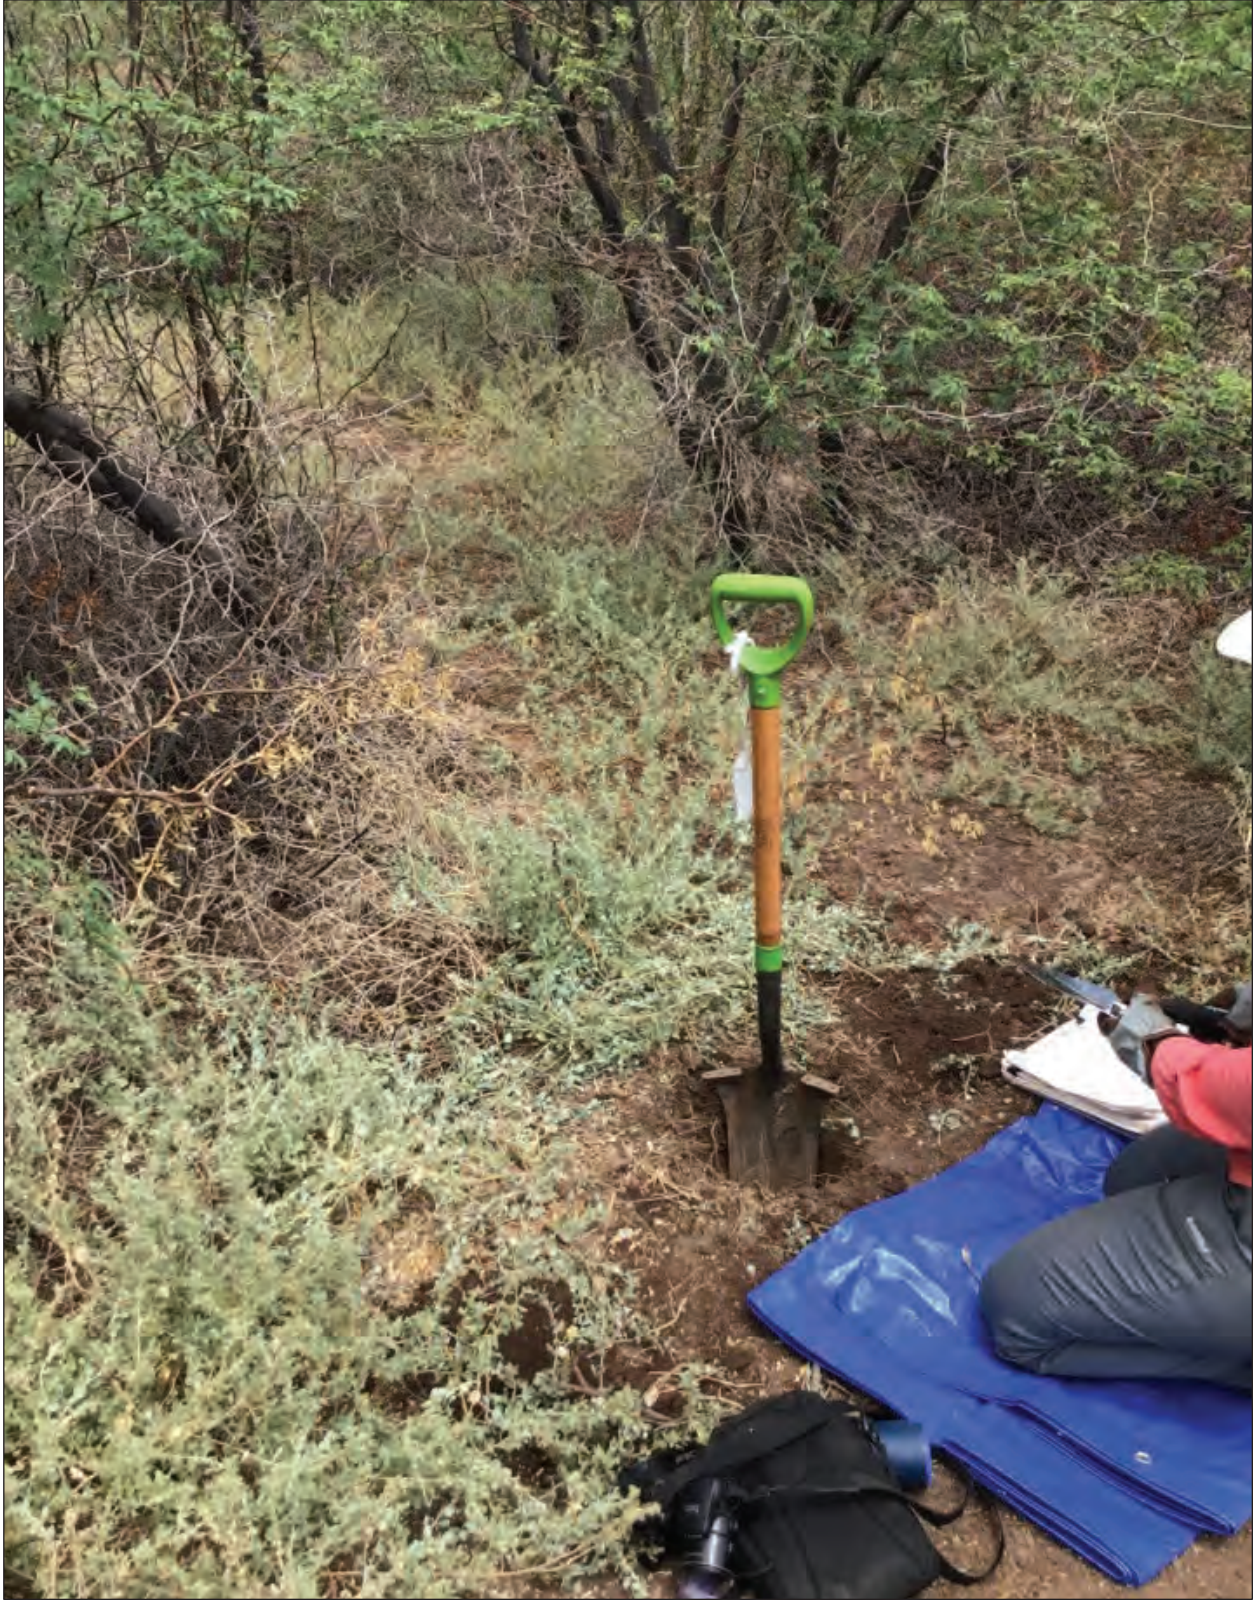
Photo 29. At SP11 - Between Berms 1 and 2; Kiawe (*Prosopis pallida*), with Predominantly Facultative Saltbush (*Atriplex semibaccata*) in Understory
