HONOAPI'ILANI HIGHWAY IMPROVEMENTS PROJECT,
WEST MAUI: UKUMEHAME TO LAUNIUPOKO

Appendix 3.9 – Water Resources, Wetlands, and Floodplains - Supplemental Information

**Honoapiilani Highway Improvement Project
Preliminary Identification of Waters of the United States
Technical Report**

Project # 4692-02

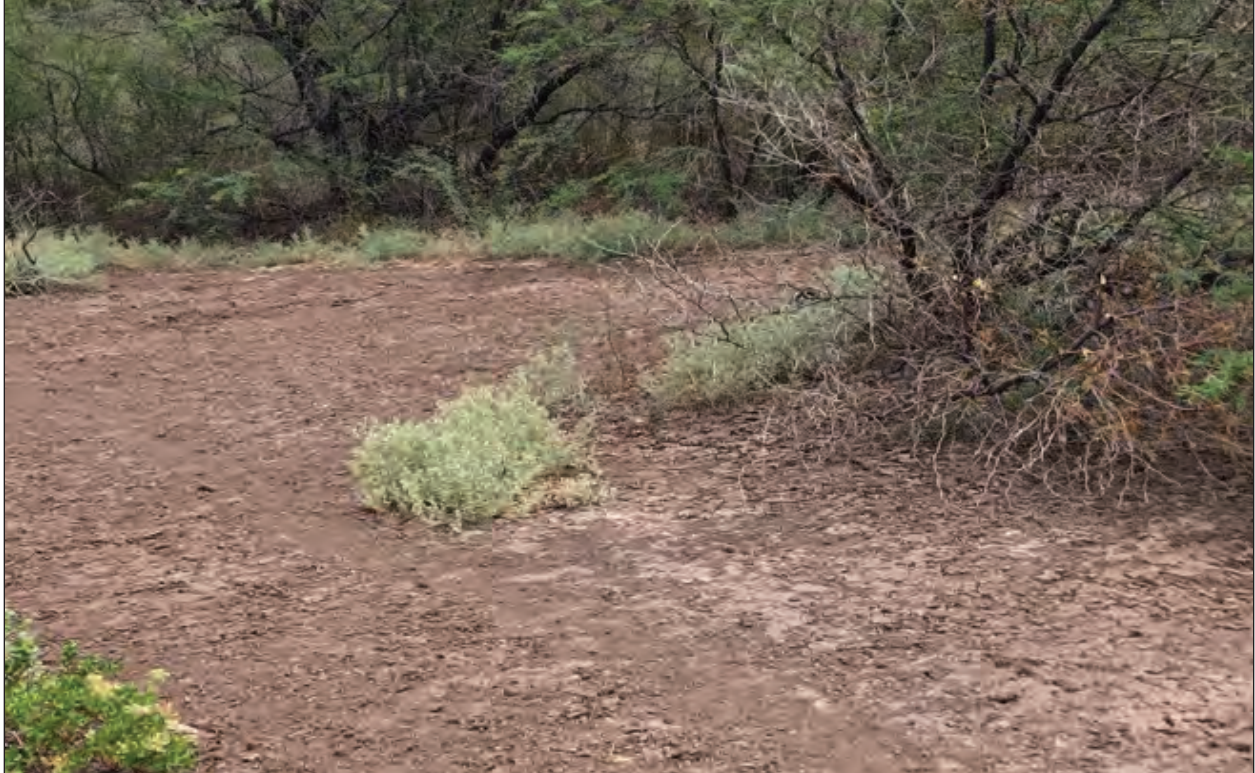
Photo 30. Around SP11 - View to East. Wetland Habitat with Surface Crack Soils and Salt Crust

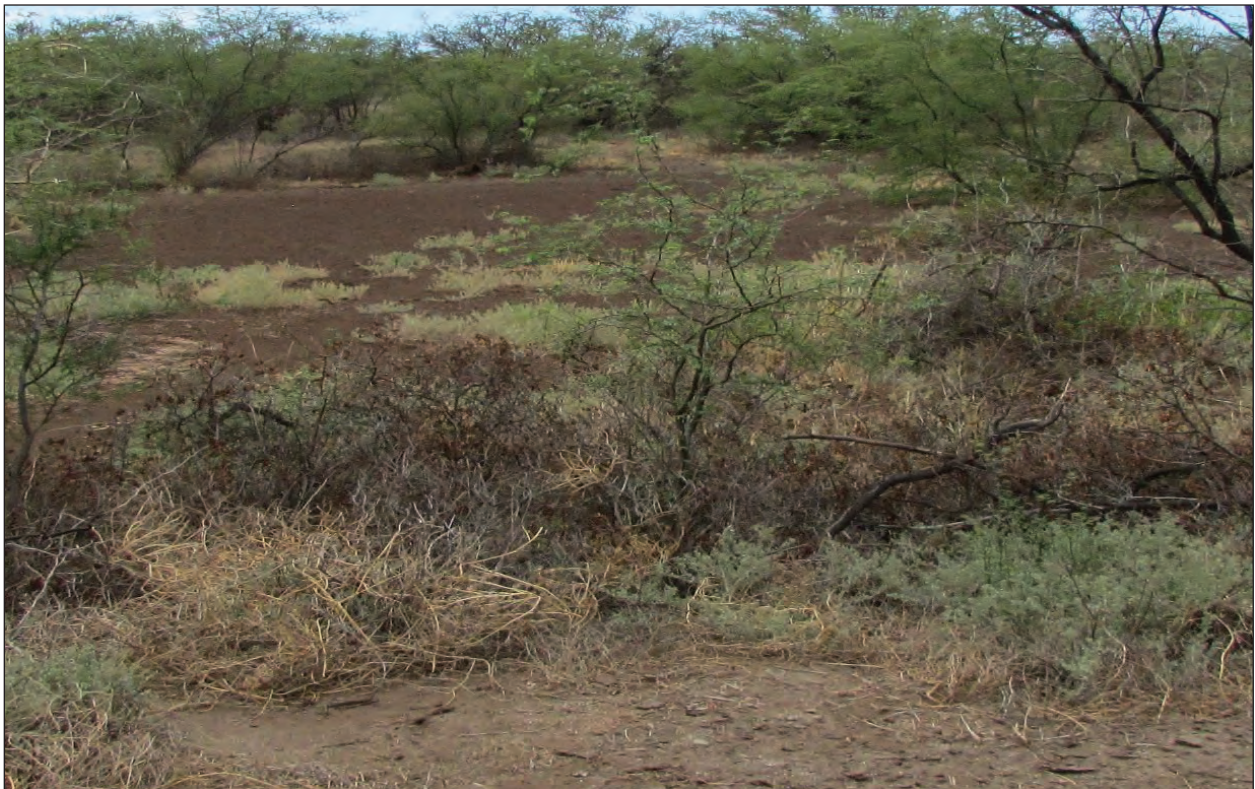
Photo 31. View to West from Top of Berm 2 into the Low-Lying Area Between Berms 2 and 3; Area Included as Wetland Based on Similar Habitat, Slope, and Hydrology Observed at SP11 Between Berms 1 and 2

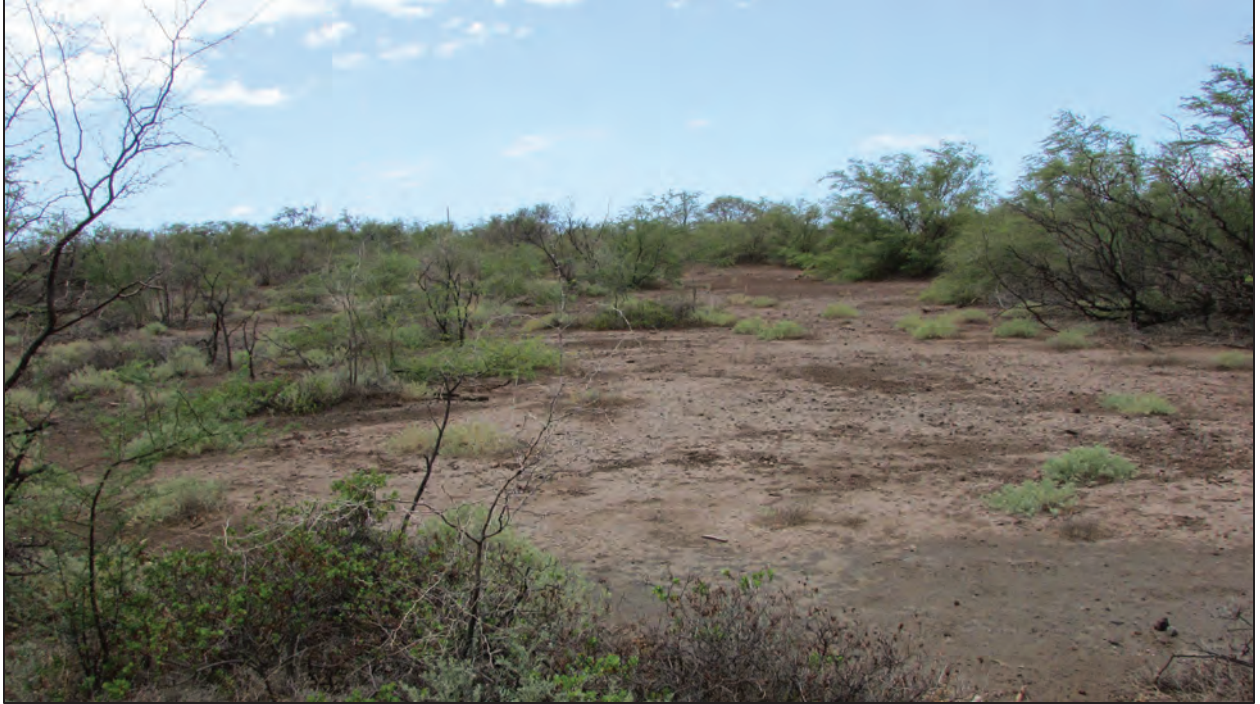
Photo 32. View to West from Top Berm 3 into the Low-Lying Area Between Berms 3 and the Western Fence of Ukumehame Firing Range; Area Included as Wetland Based on Similar Habitat, Slope, and Hydrology Conditions Observed at SP11

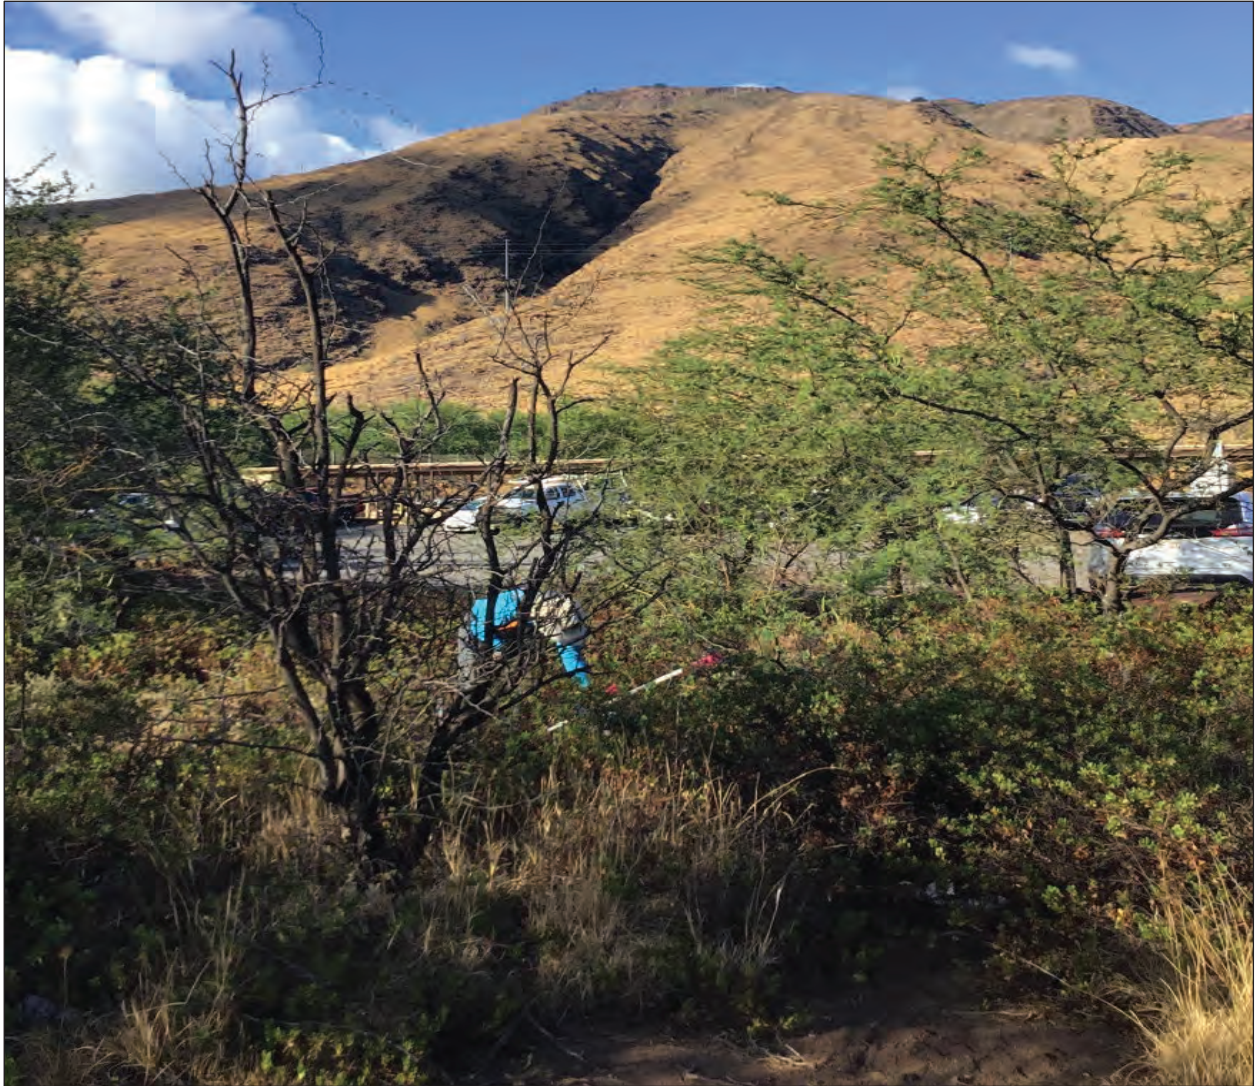
Photo 33. At SP13 – View to East; This Upland Area in the Disturbed Swath Next to the County Firing Range Parking Lot Defined the Edge of the Wetland to the West

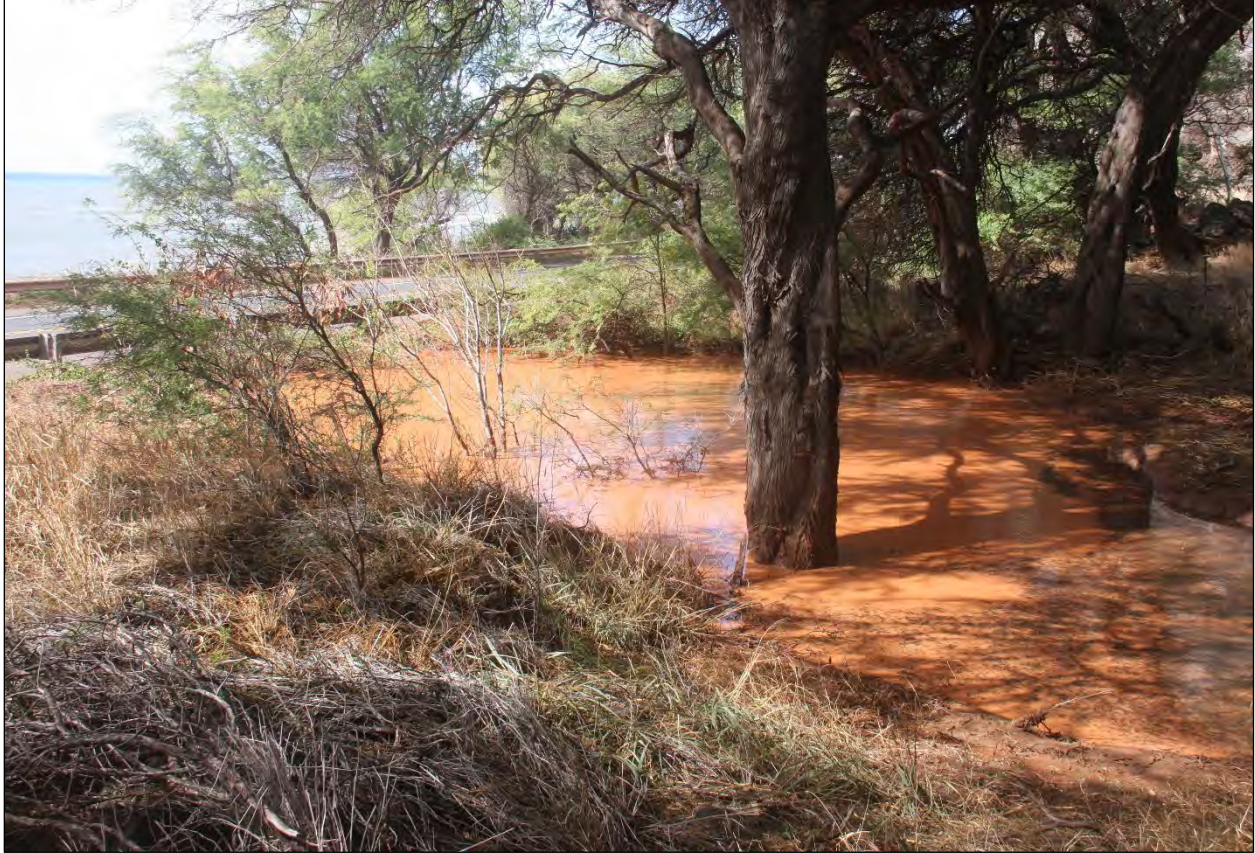
Photo 51. Ponded and Backed Up Stream on December 20, 2022 Following Heavy Rains

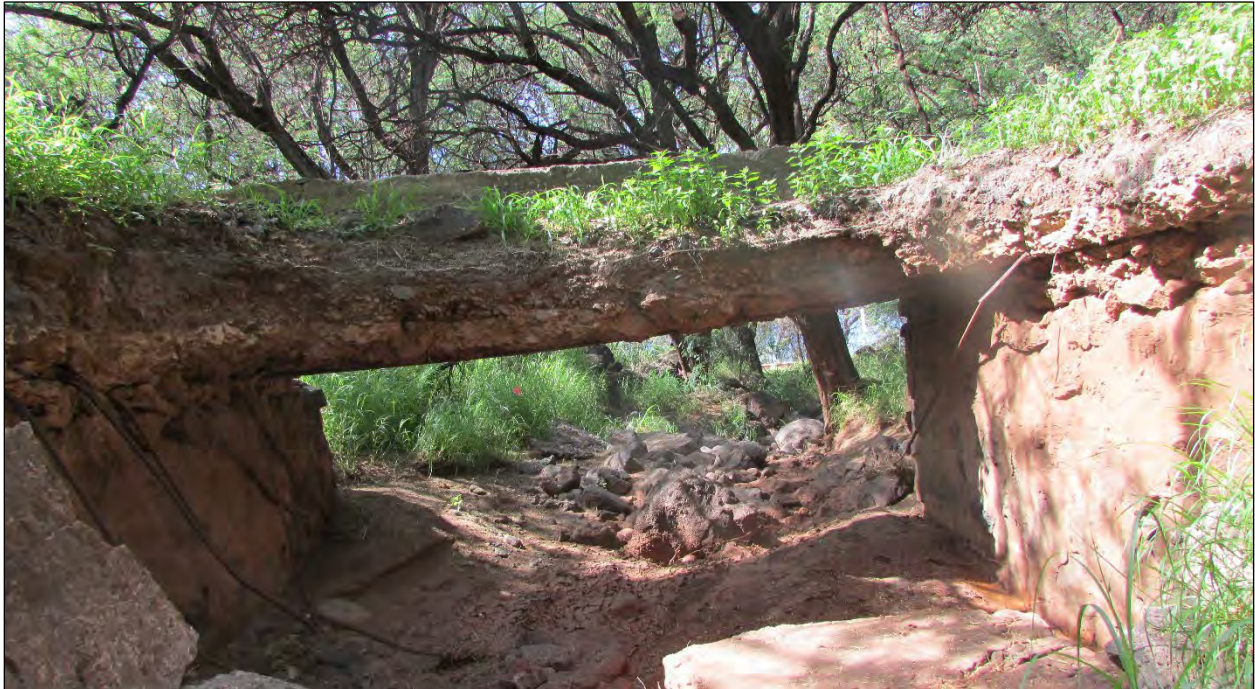
Photo 52. Remnant of an Old Concrete Bridge at the Upper (Eastern) End of the Stream in the Study Area. [Water and sediment staining used to identify the OHWM level here.]

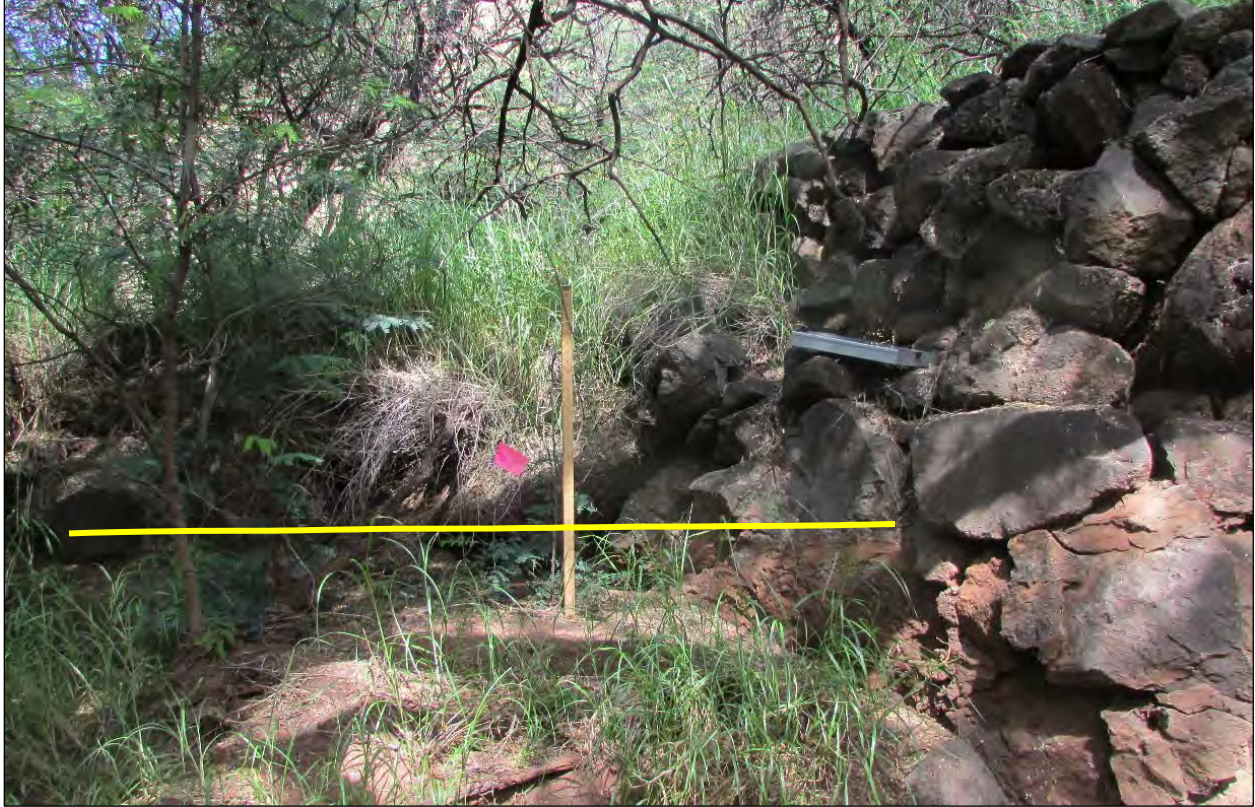
Photo 53. Location of Transect 1; Sediment/Water Staining on the Rocks at the OHWM and Wracking of Debris Above the OHWM were Used to Mark the OHWM Level Here

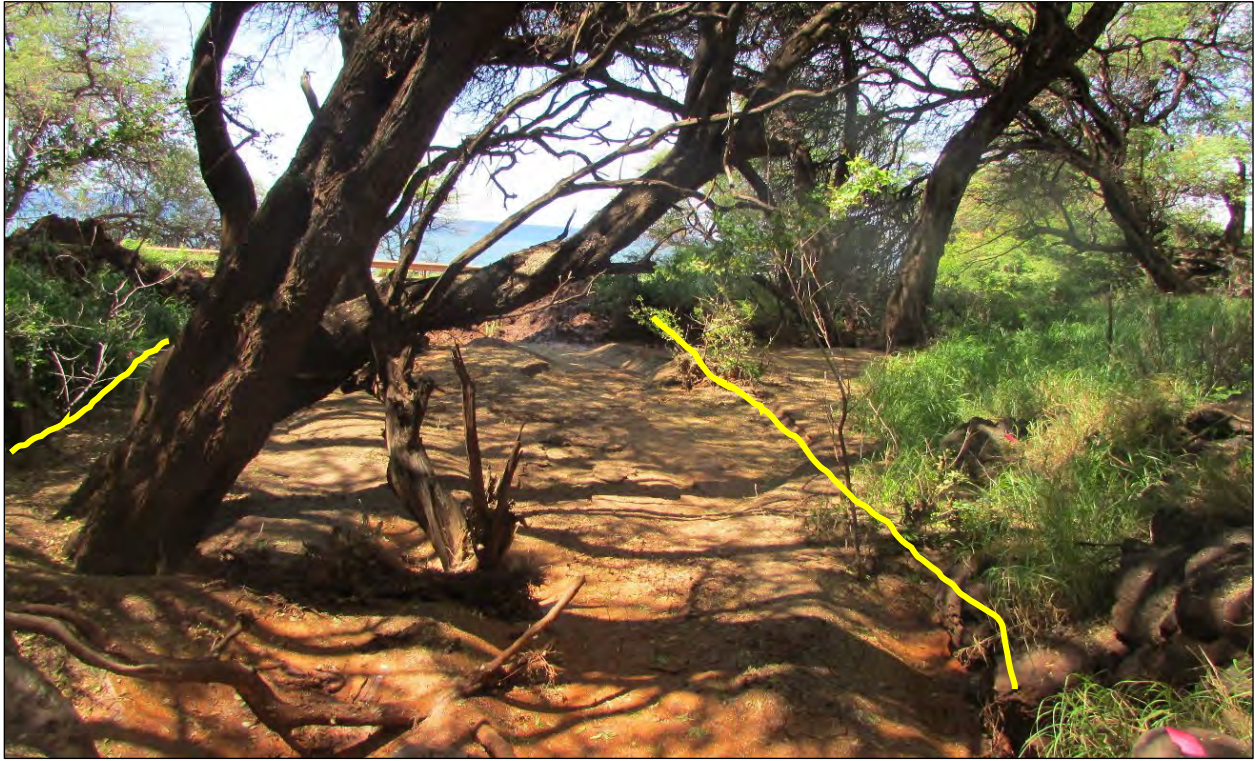
Photo 54. Location of Transect 2; Placed Where Indicators Such as Vegetation Destruction were Selected to Mark the OHWM Level

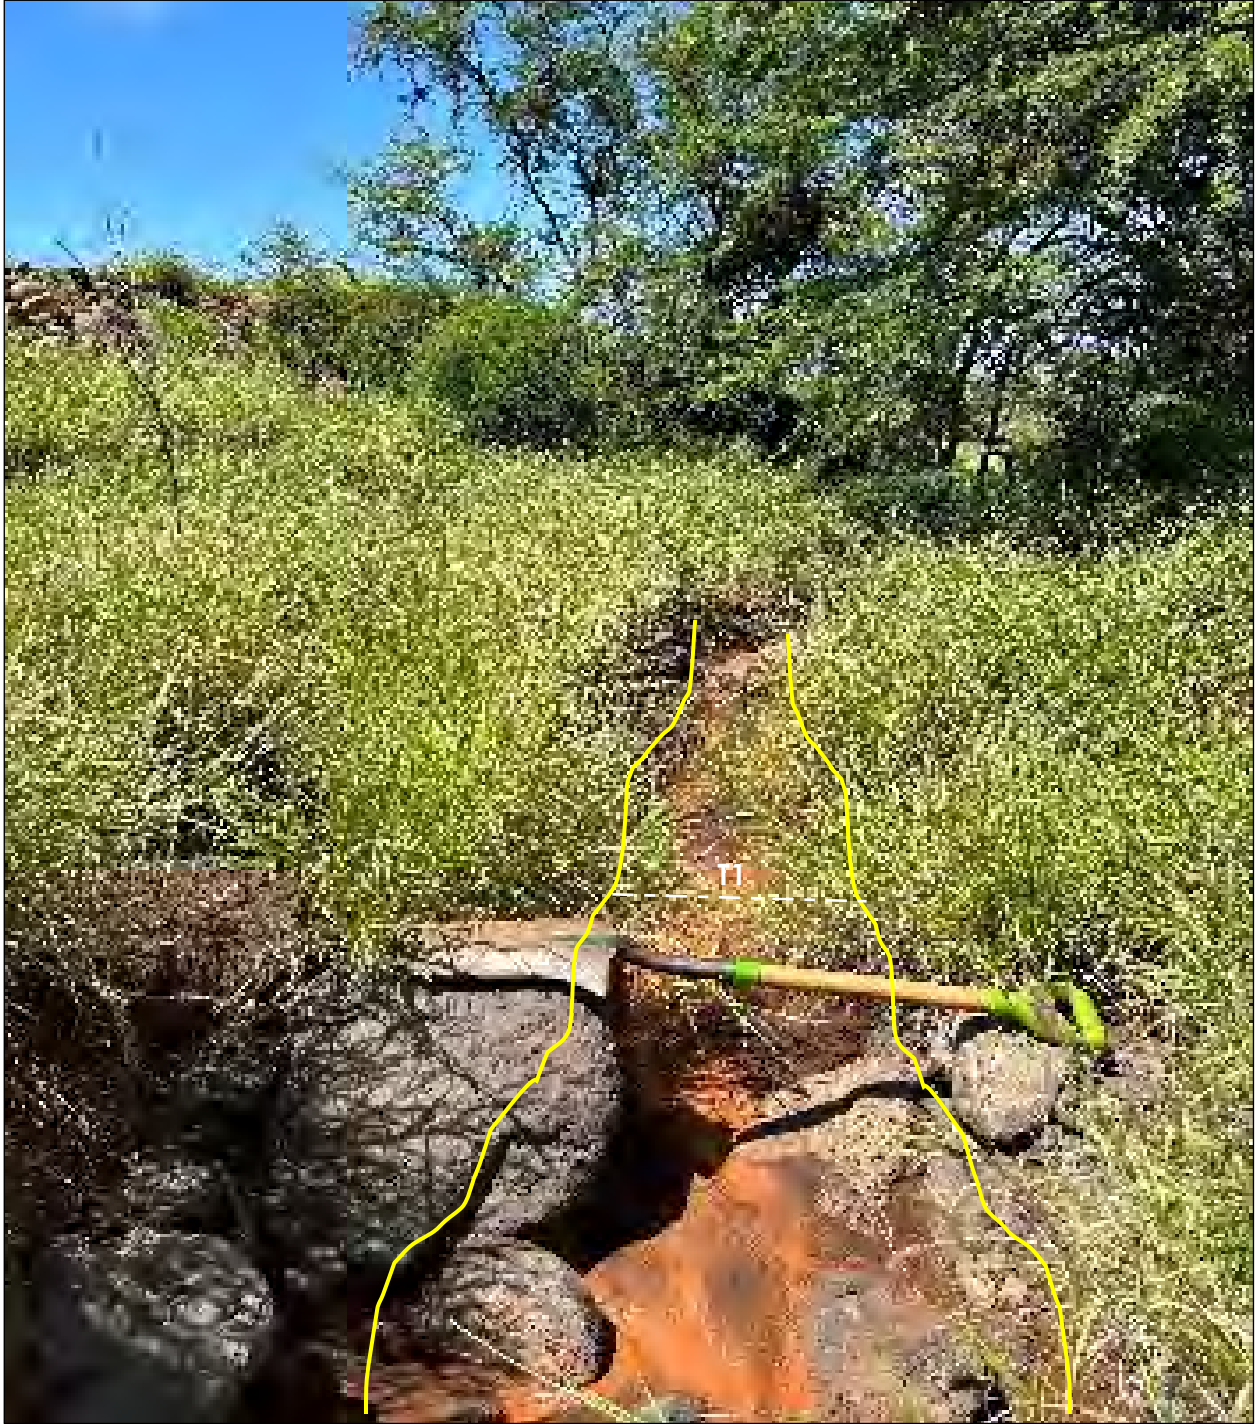
Figure 55. Papalaua Gulch – Location of Transect 1 on Southern Unnamed Stream; Stream Flow Here is in the East West Direction Before it Turns North Along the Raised Berm of the Sedimentation Basin

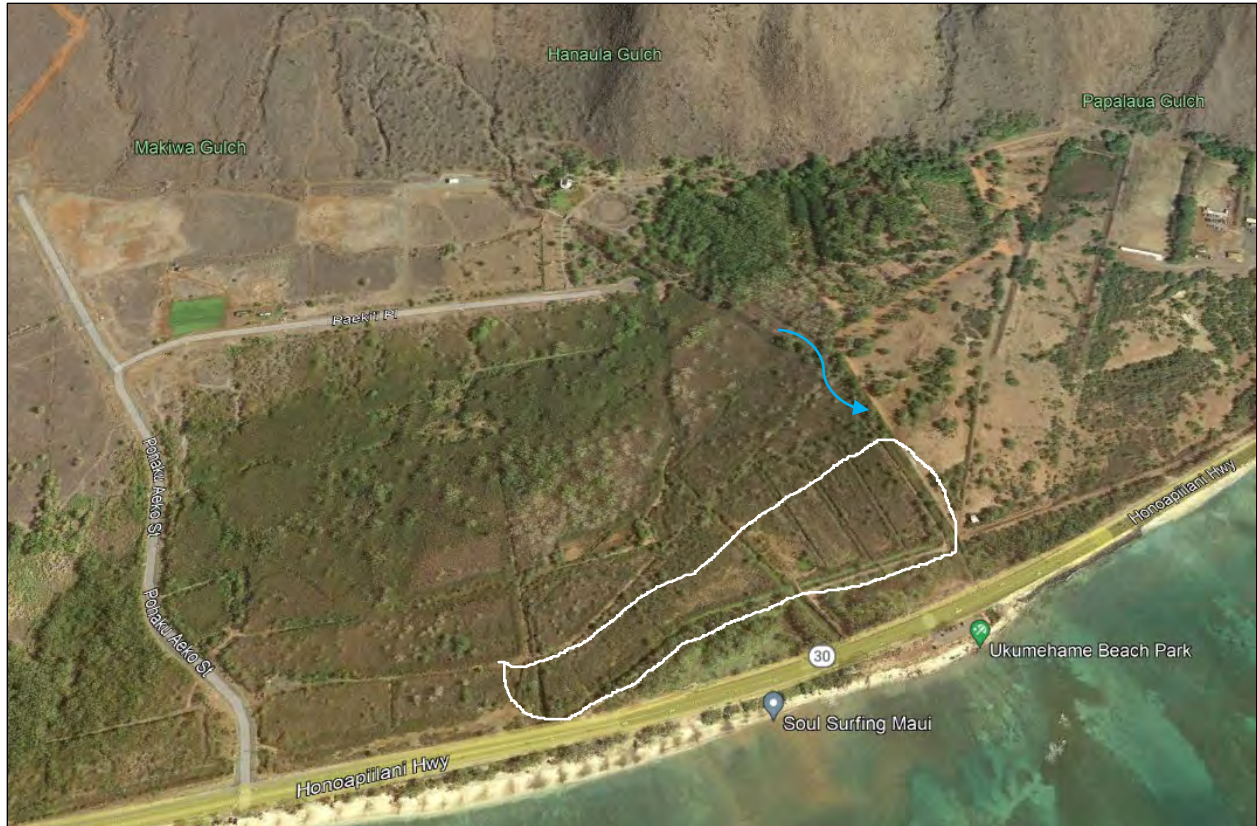
Photo 61. Google Earth Imagery - Hanaula Gulch (Blue Arrow) and Associated Ditches. D1 to D7 (White Outline) [Landscape View of Hanaula Stream Flow into the Ditch (Blue Arrow) that Runs Parallel to the Northern Boundary of Ukumehame Firing Range]

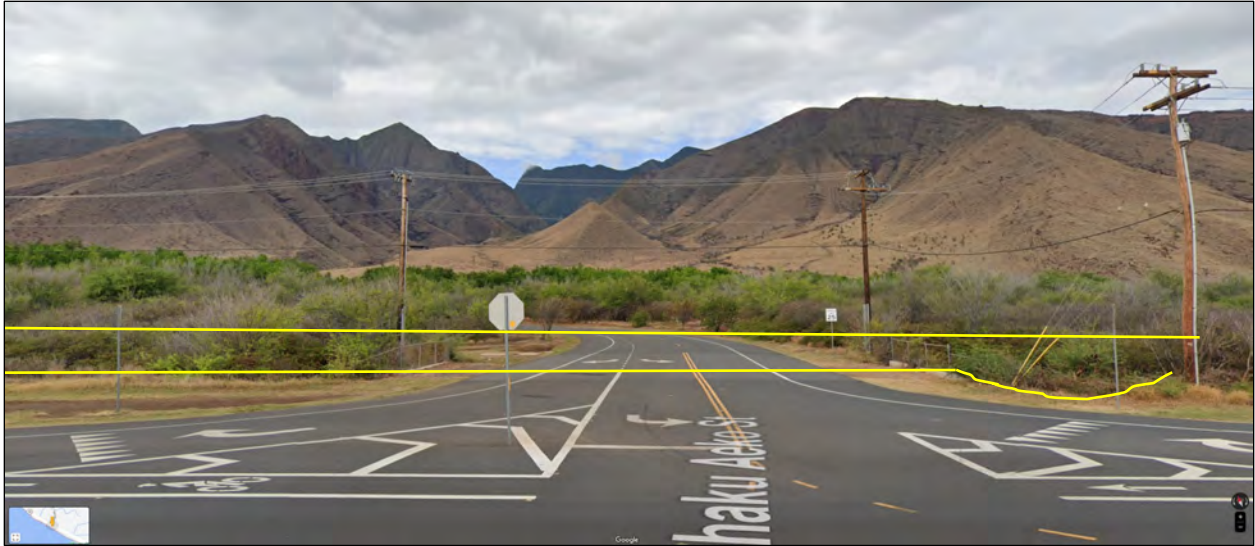
Photo 65. Ditch 8 at Pohaku Aeko Street. [Ditches on Either Side of Pohaku Aeko Street Are Connected Via a Concrete Culvert. Also, the Ditch to the South [Right] of the Road Flows Under the Existing Highway into the Pacific Ocean.]

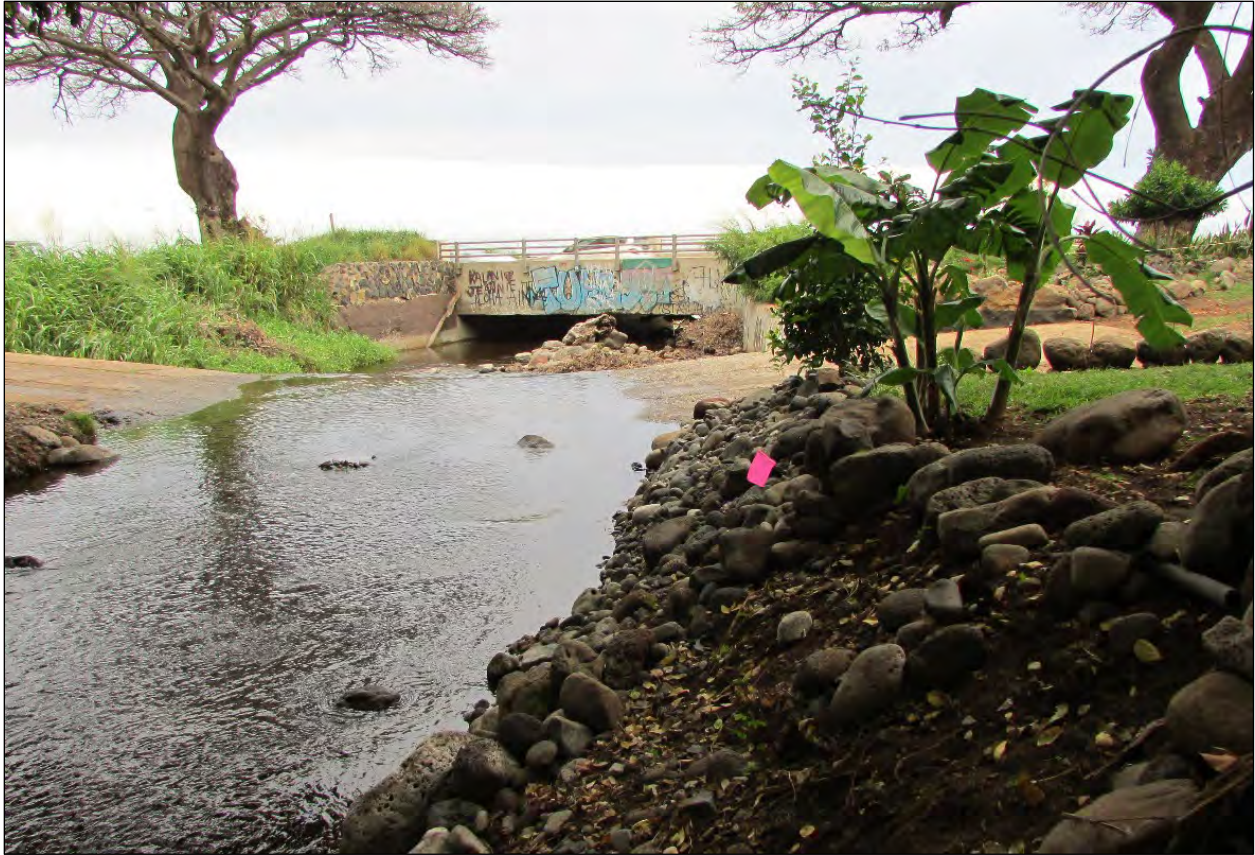
Photo 73. Location of Transect 3 at Lowermost Reach of Stream; Ukumehame Stream Bridge and the Concrete Ford at the Lowermost Reach (The Bridge Footing and Water Staining on the Concrete Defined the OHWM Level for this Lower Reach)

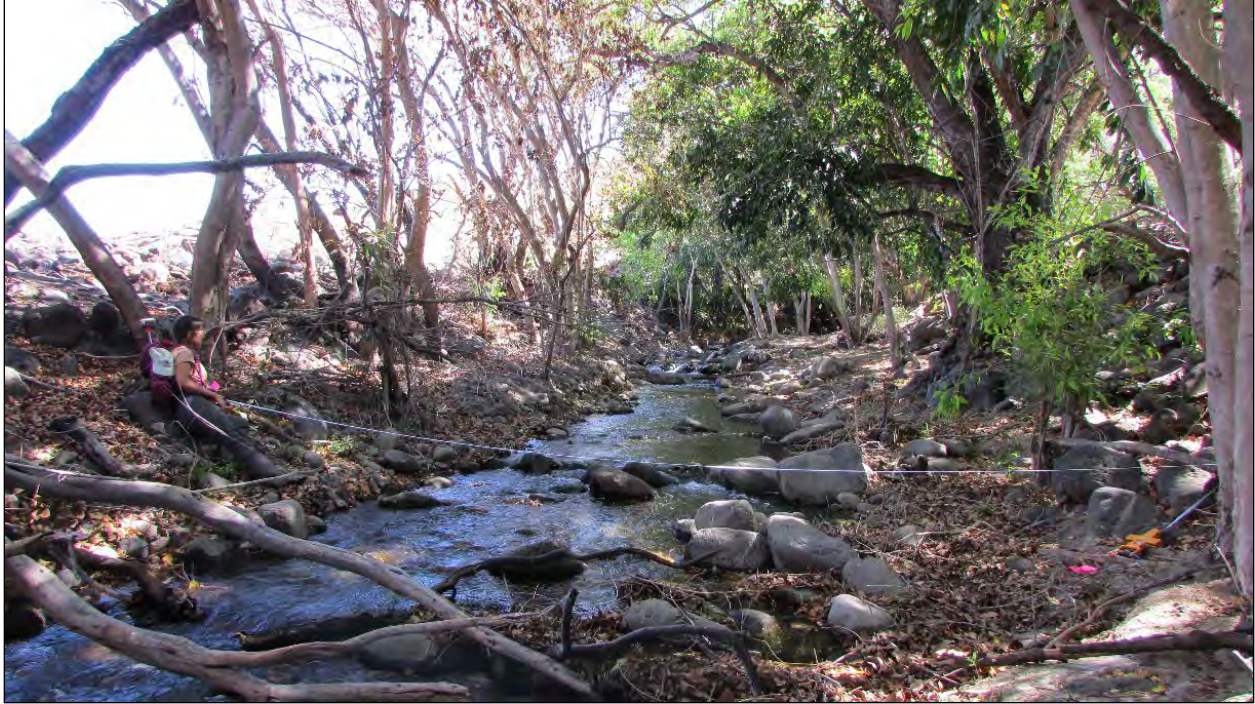
Photo 82. Location of Transect 1; Representative of the Portion of the Stream with Runs Overlapping the Innermost Build Alternative 4 (Burned Trees from the Fires in June-July 2023 Visible on the North (Left) Bank

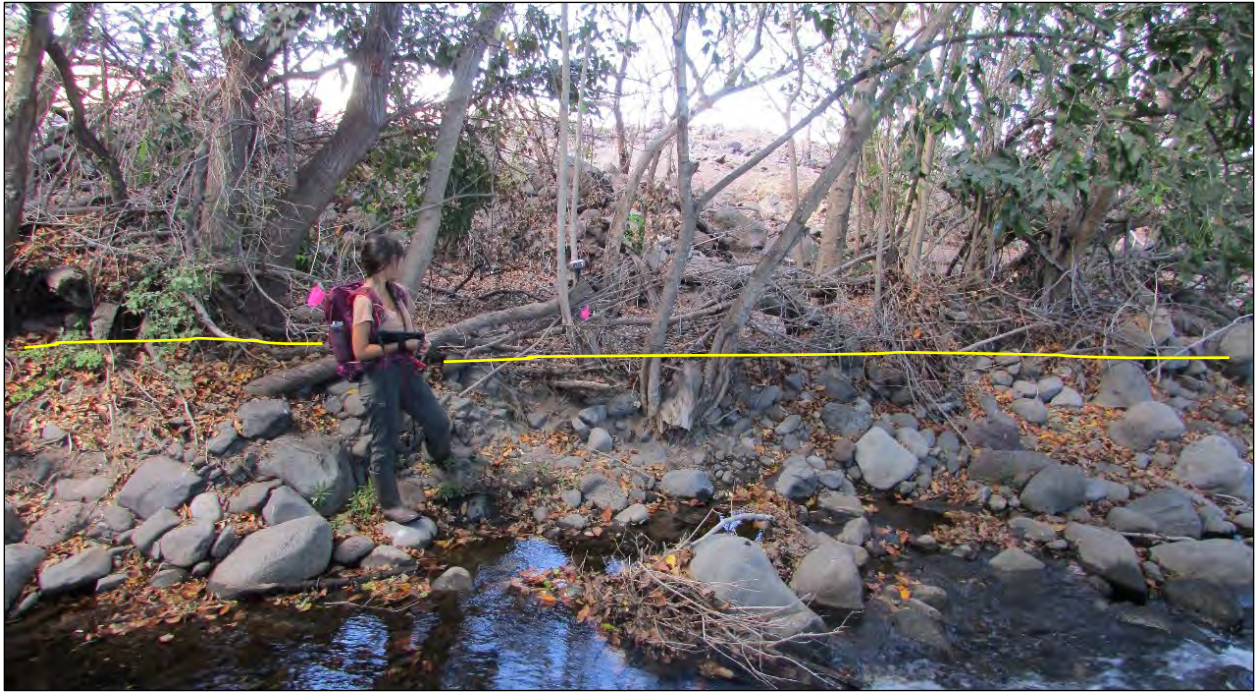
Photo 83. Indicator of Accumulation of Large Debris at the OHWM Level in the Up Stream Section of the Study Area

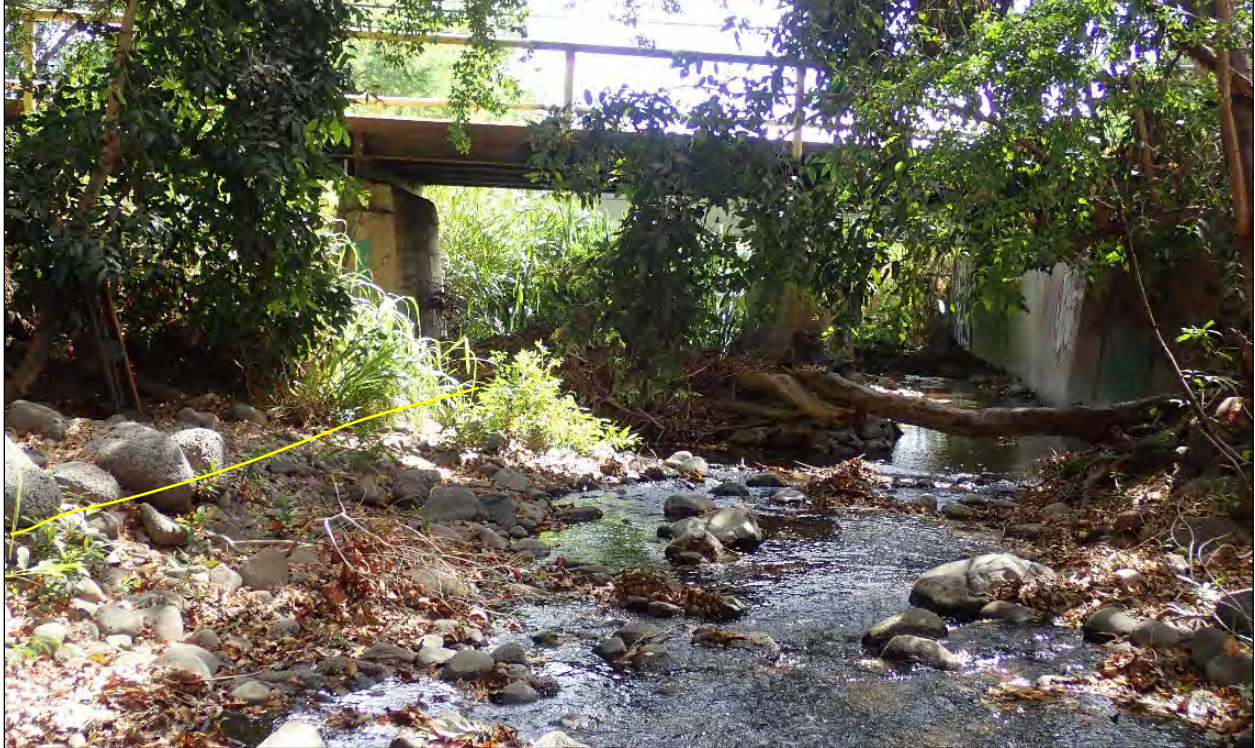
Photo 86. Location of Transect 3 At the Olowalu Stream Bridge; Sediment Staining on the Concrete Bridge Contributed to Determining the OHWM Level in this Area

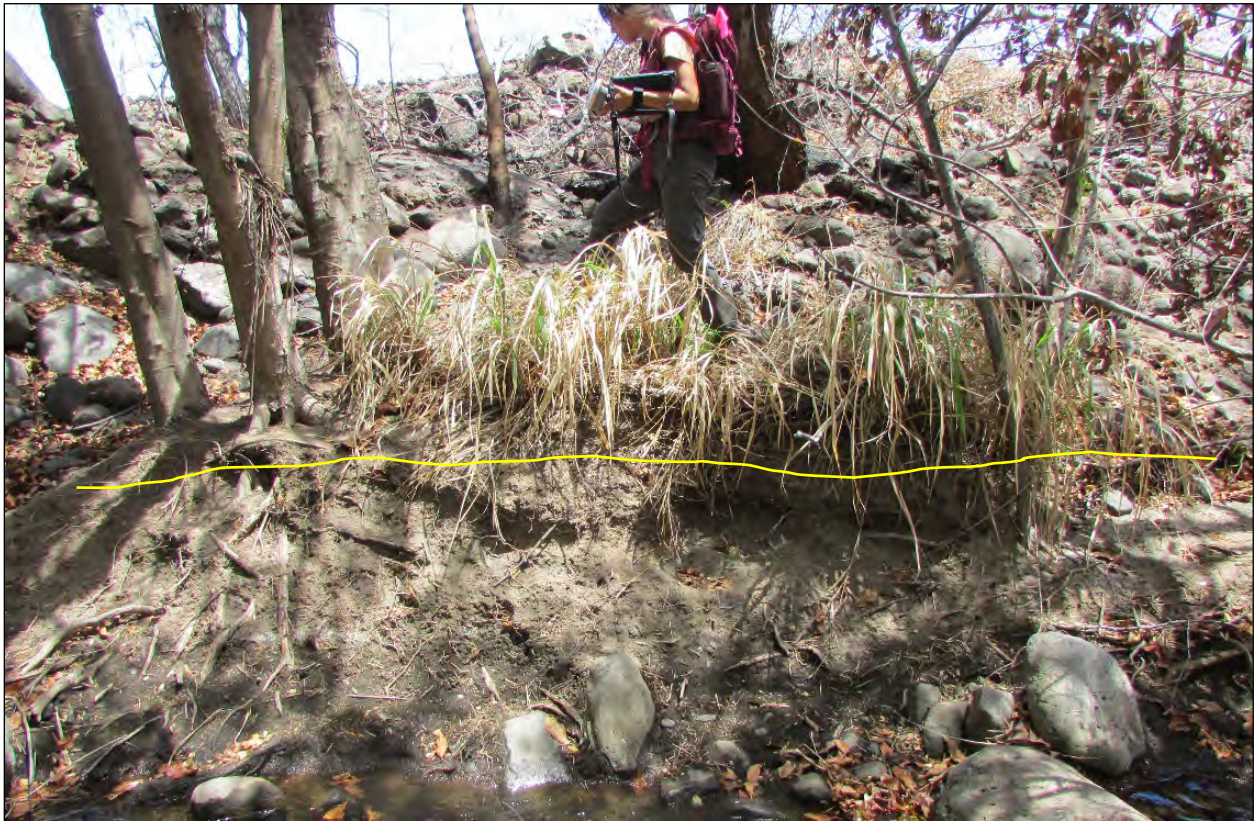
Photo 87. Undercut Banks with Exposed Roots Was Key in Separating Impacts from Confounding Soil and Wind Erosion Caused Due to Recent Fire

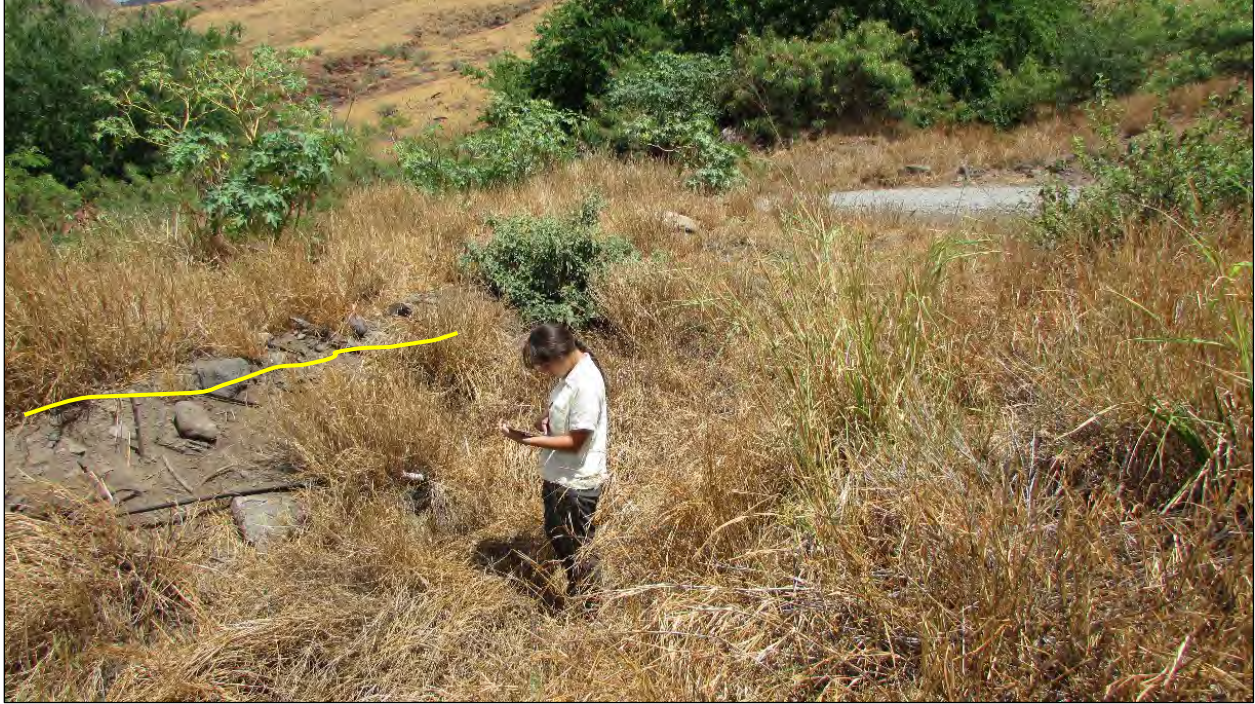
Photo 88. Location of Transect 1; Representative of the Uppermost Reach of the Stream in the Study Area (Break in Slope and Washed of Debris Were Used as Indicators of OHWM)

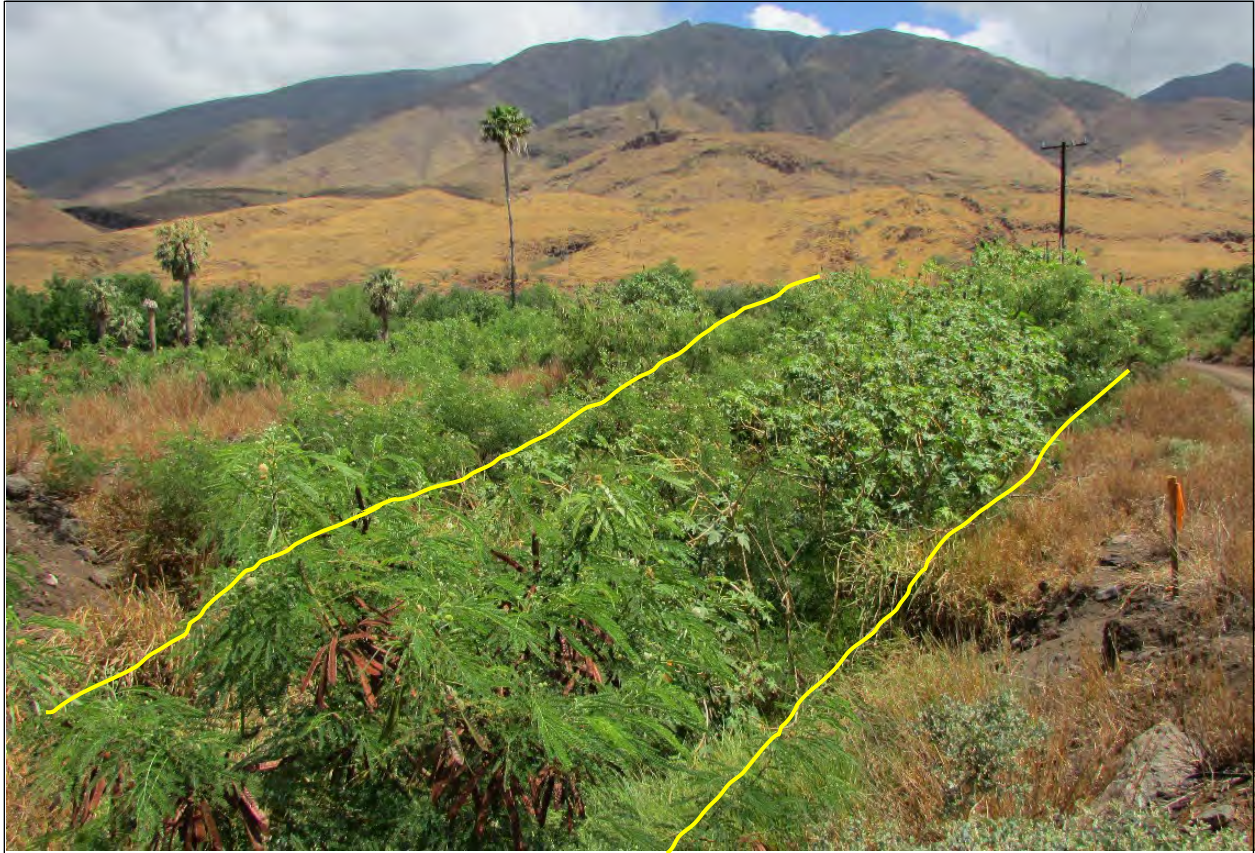
Photo 90. Location of Transect 2 at the Lower/Western Reach of Lihau Stream in the Study Area; Heavily Vegetated Moist Bed Compared to the Upper Drier Banks and Break in Bank Slope Used as OHWM Indicators

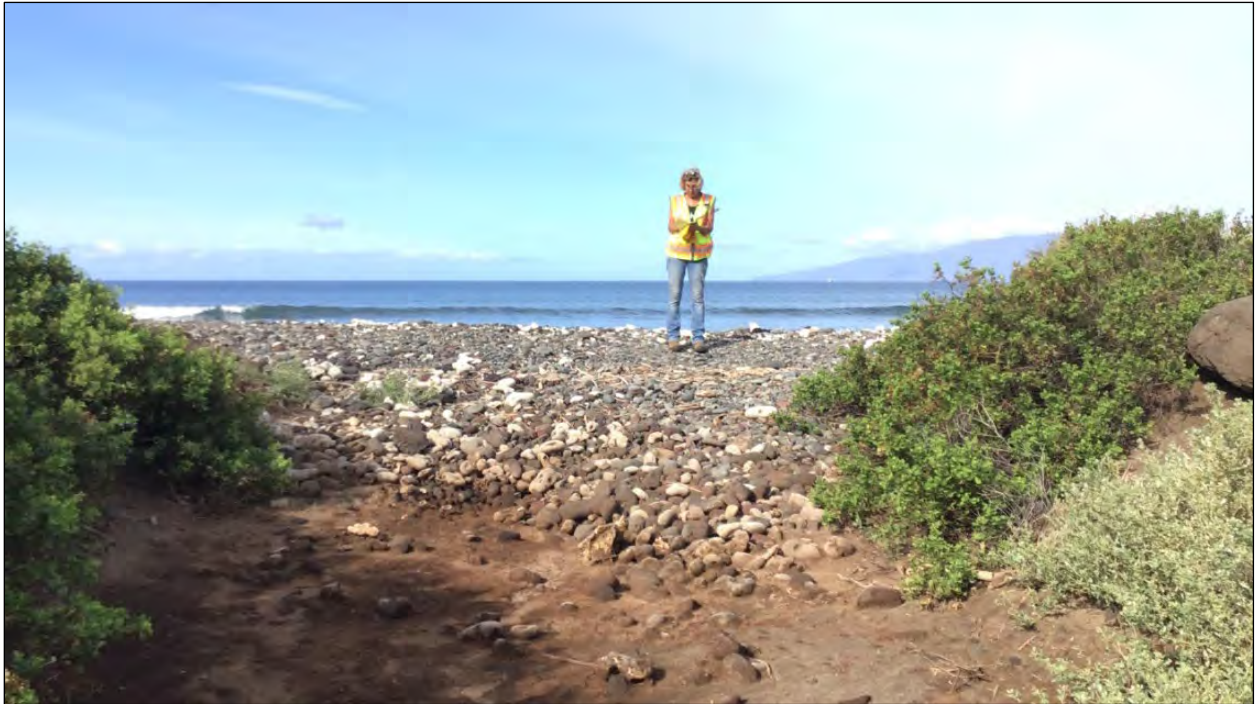
Photo 91. Lihau Stream Entering the Pacific Ocean in the Western Most Portion of the Study Area

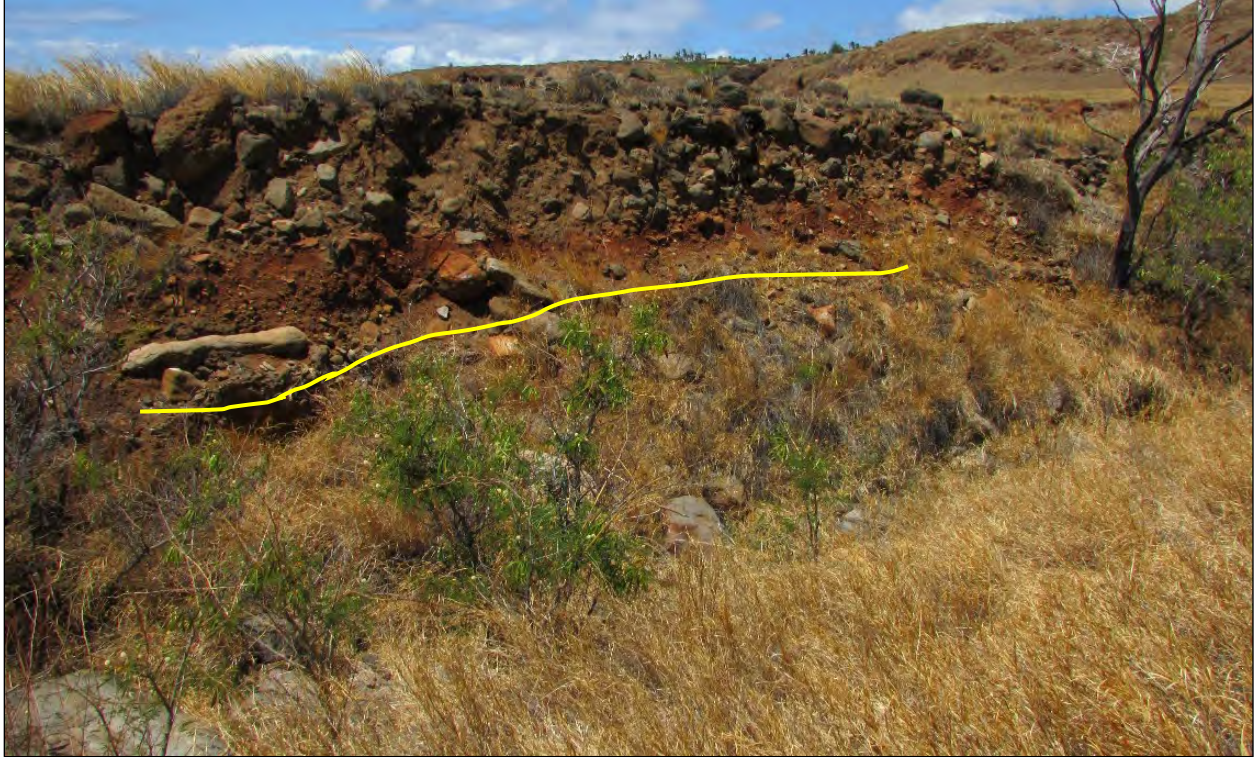
Photo 94. Awalua Stream Location of Transect 2 in the Upper/Eastern Reach of Stream in Study Area; the Dry Vegetation in the Bed was Indicative of Moisture Levels that Supported Plant Growth in the Bed and Helped Distinguish Between Erosional Features and OHWM Level

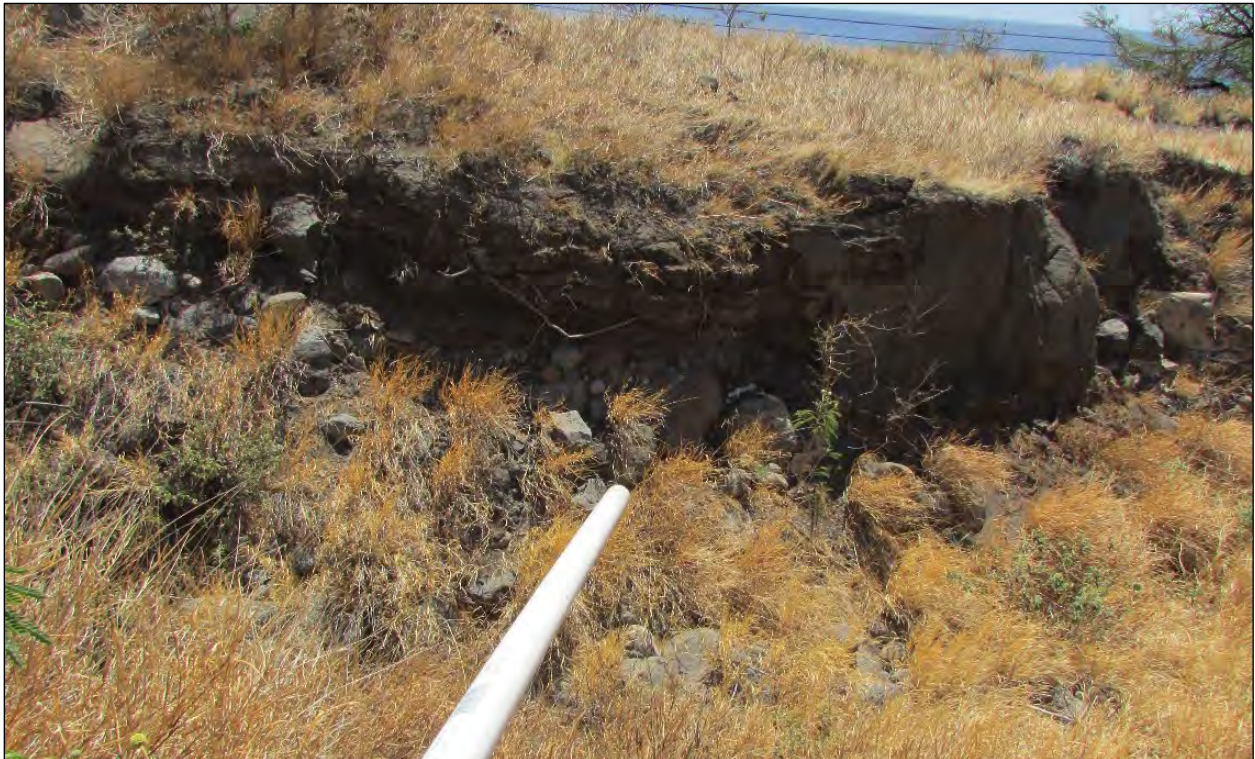
Photo 95. Awalua Stream Undercut Bank; Vegetation Line Together with Undercut Bank Allowed for Identifying OHWM Level Here

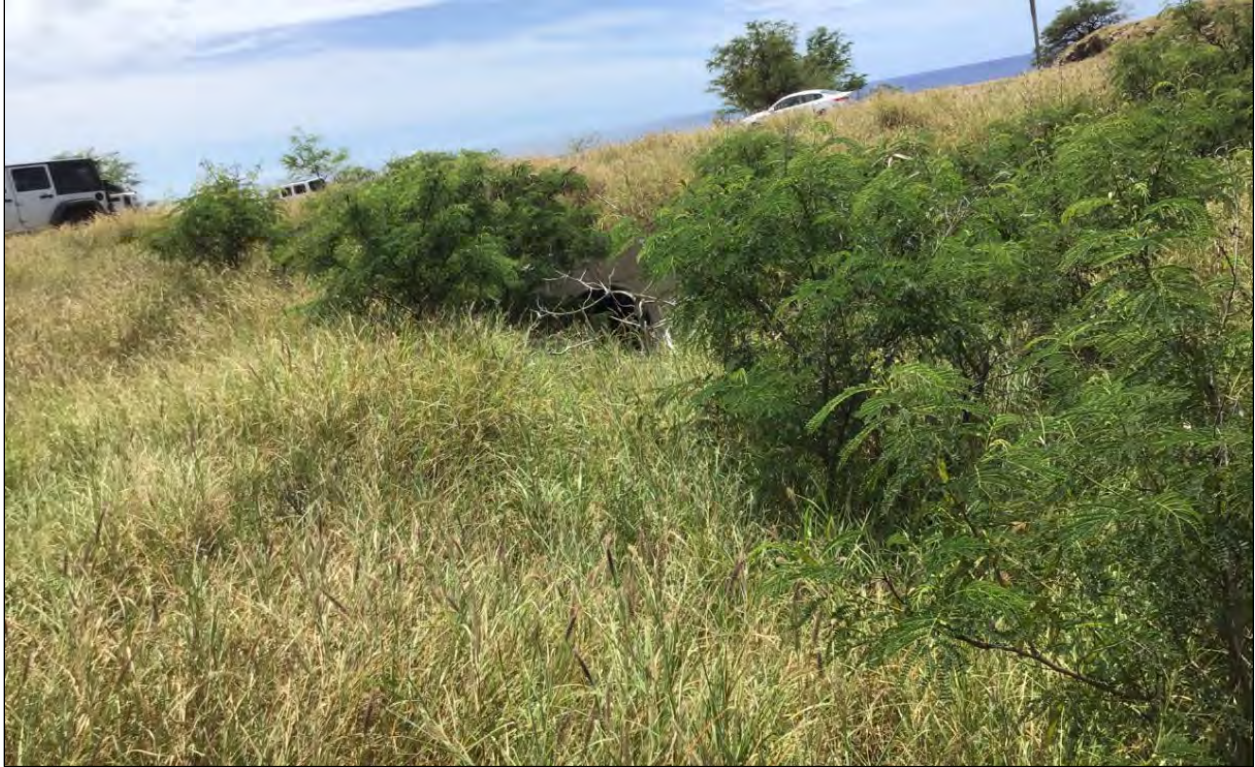
Photo 96. Ka Puali Stream – West View with Concrete Culvert; Location of Transect 1 (Heavily Vegetated Bed with Shrubs and Bank with Grasses)
