HONOAPI'ILANI HIGHWAY IMPROVEMENTS PROJECT,
WEST MAUI: UKUMEHAME TO LAUNIUPOKO

Appendix 3.9 – Water Resources, Wetlands, and Floodplains - Supplemental Information

**Honoapiilani Highway Improvement Project
Preliminary Identification of Waters of the United States
Technical Report**

Project # 4692-02

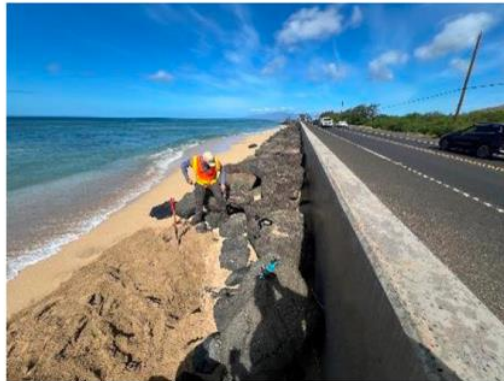
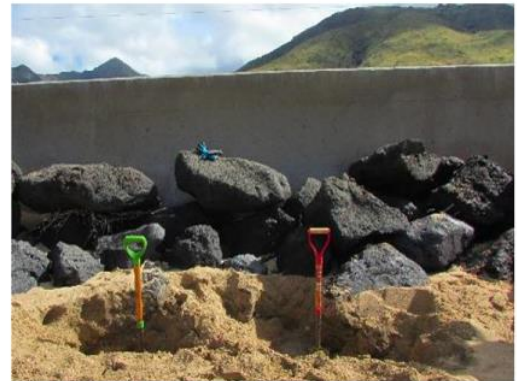
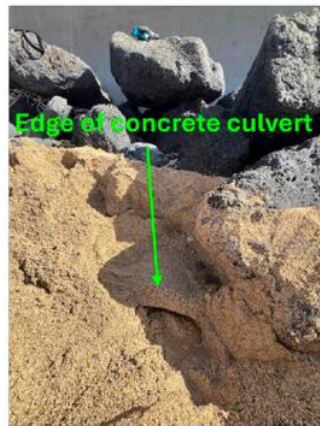
Figure 5: Photos of Location 1a

Photo depicting the sand blocking the culvert at Location 1a.

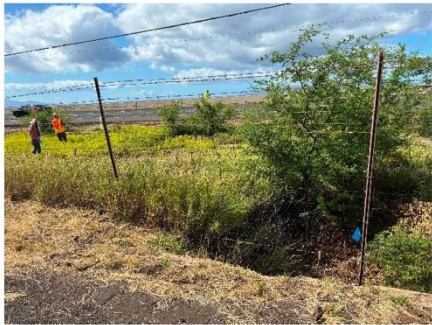
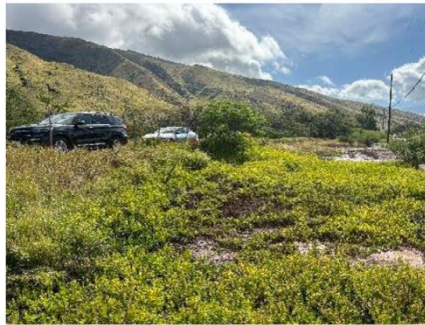
Pickleweed and saturated soils between Locations 1b and 2a.
